FACILITY CONDITION ASSESSMENT

City of Mobile

Facility No: 533

Herndon Park Maintenance/
Concession/Restroom Buildings
2900 Dauphine Street
Mobile, Alabama 36606

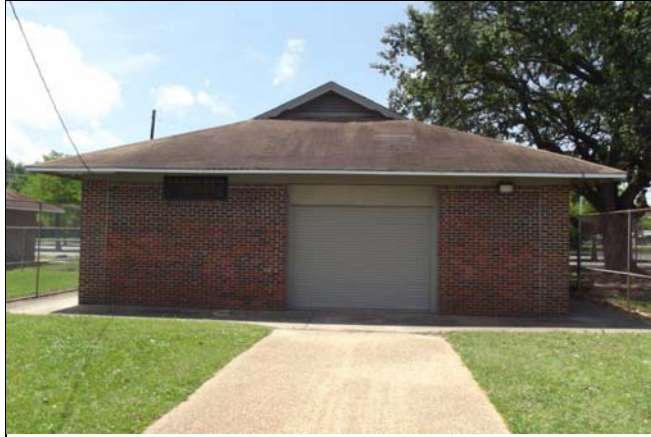
1. The Herndon Park maintenance office as viewed from the rear.

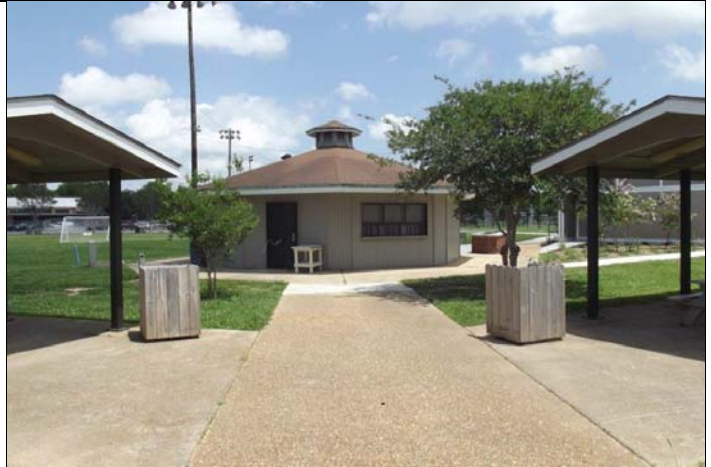
2. The Subject also includes the concession stand building.

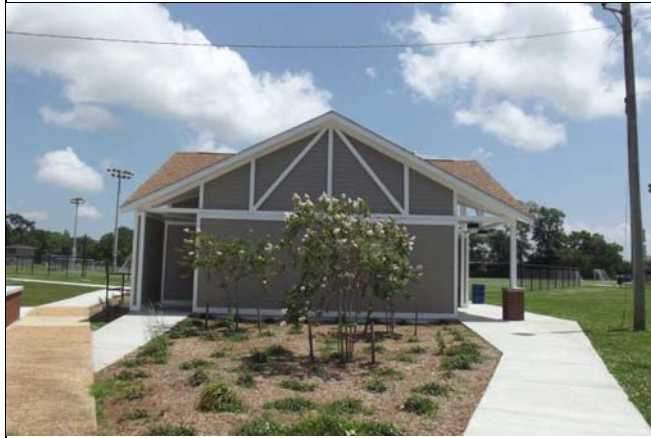
3. A new restroom facility is included with

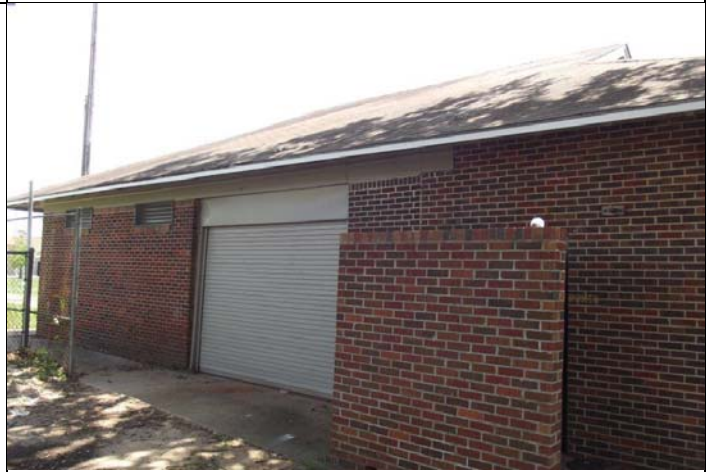
4. The Herndon Park Maintenance is clad with brick.

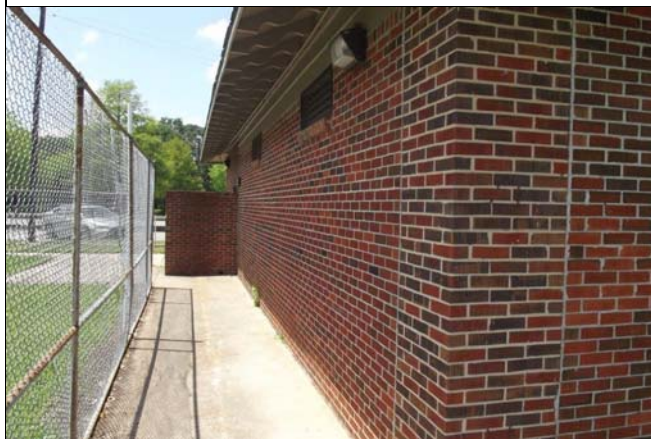
5. Concrete sidewalks are located alongside the building.

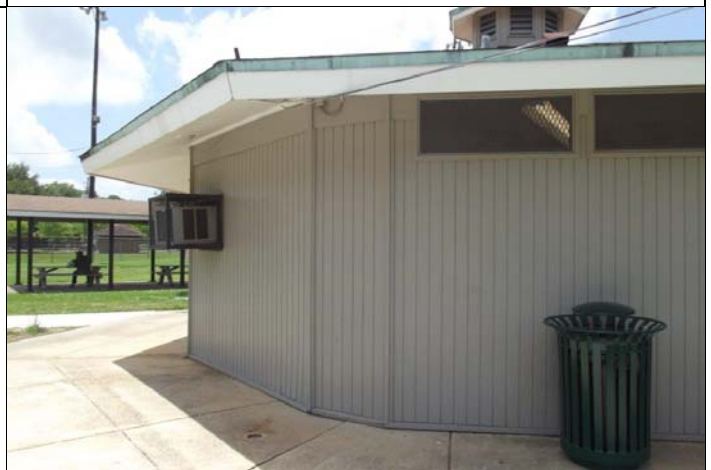
6. The concession stand is clad with wood panel siding.

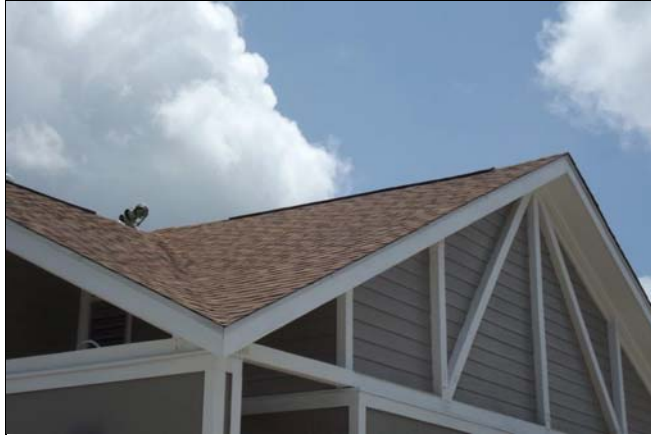
7. Roofing systems consist of asphalt shingles of various ages.

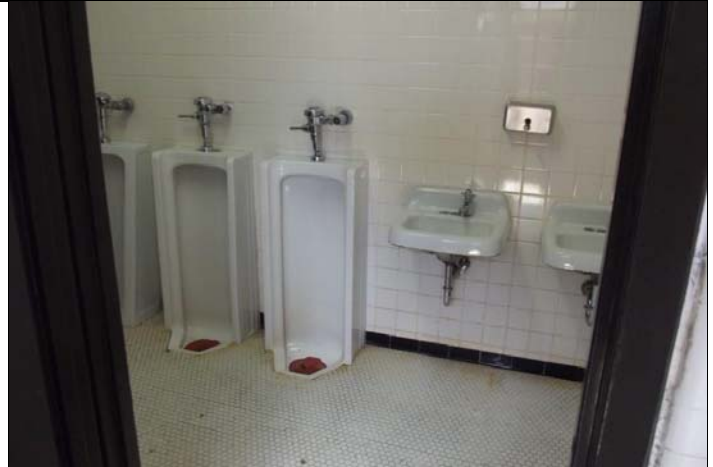
8. Interior of the Men's toilet room in the Maintenance Office building.

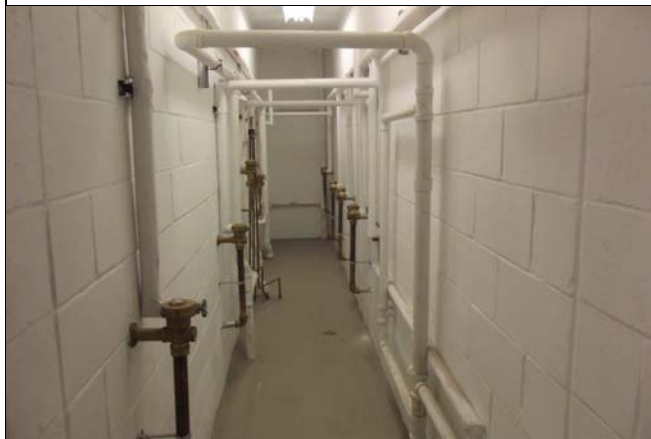
9. The utility chase area of the new toilet room building.

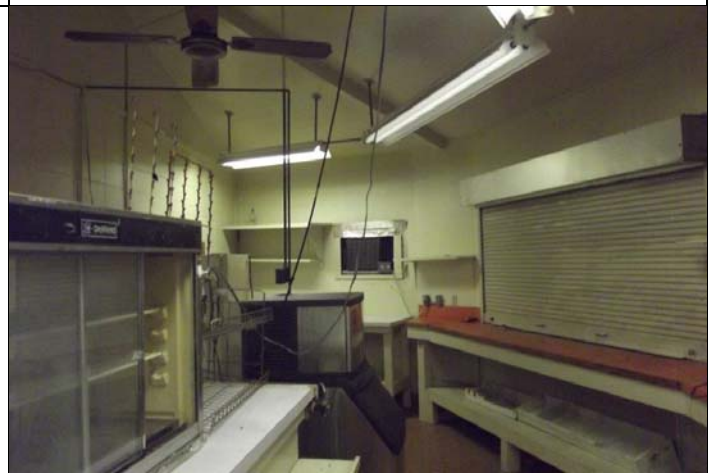
10. Interior of the Concession Building.

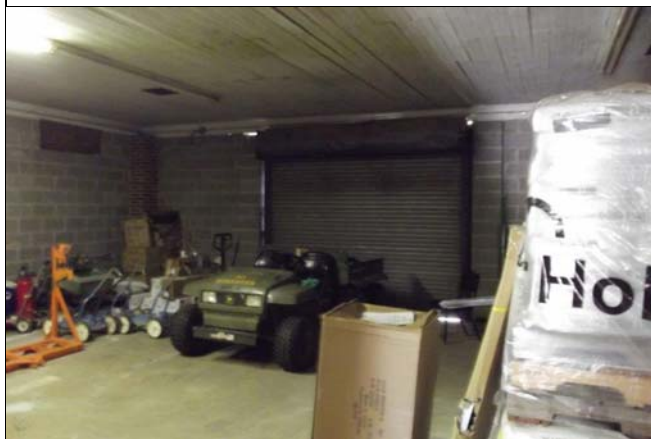
11. Interior storage area of the Maintenance Office Building.

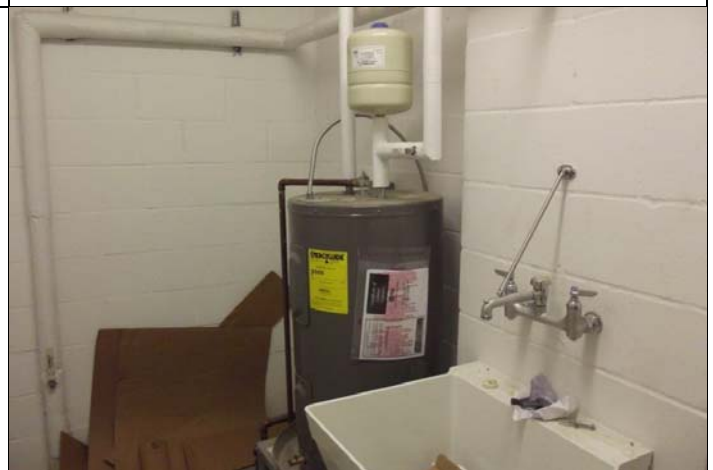
12. Domestic water heater in the Toilet Room building.

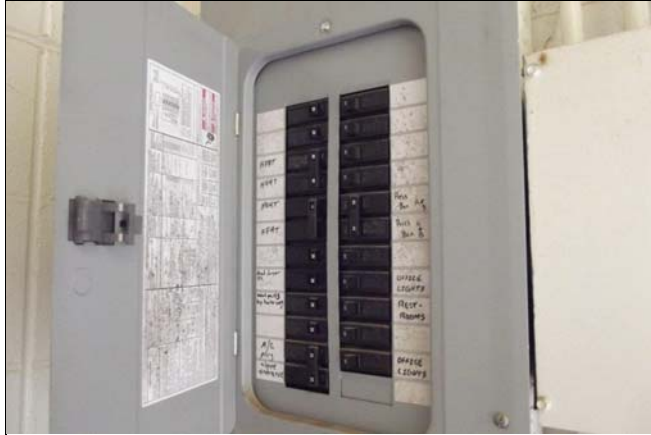
13. Typical electrical panel.

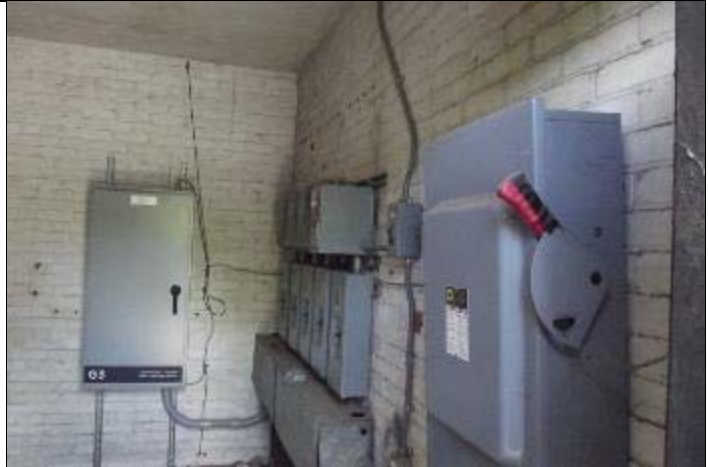
14. Main electrical switchgear in the electrical room.

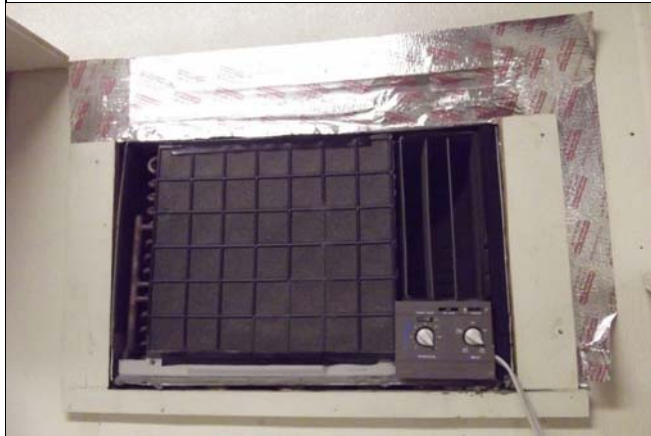
15. Heating and air conditioning is provided by through-wall package units.

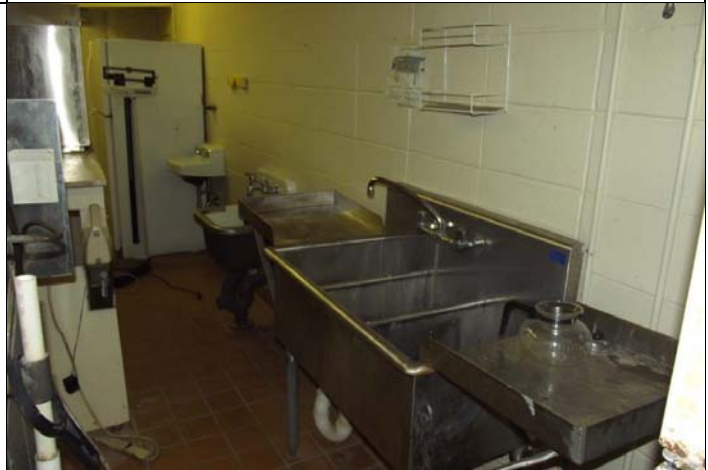
16. The kitchen area of the Concession Building.

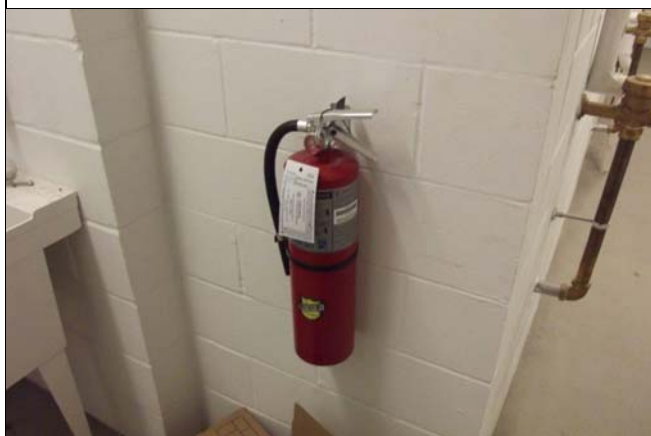
17. Fire protection is provided by portable fire extinguishers.

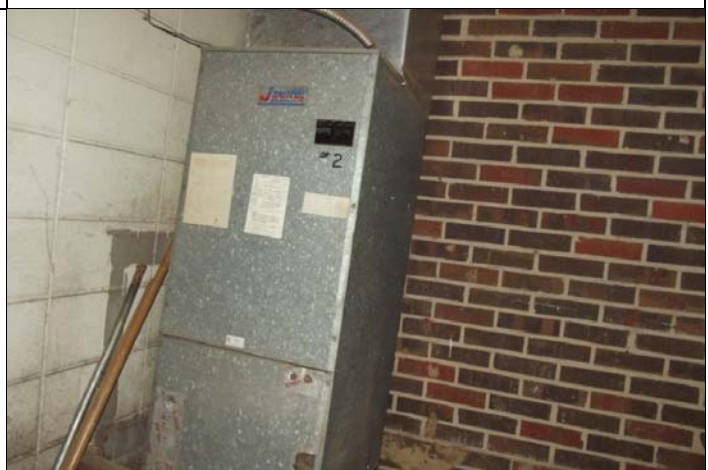
18. The Maintenance Office building has a split system which is abandoned-in-place.
