# FACILITY CONDITION ASSESSMENT

Ashland Place Fire Station No. 12

2407 Old Shell Road

# Facility Condition Assessment

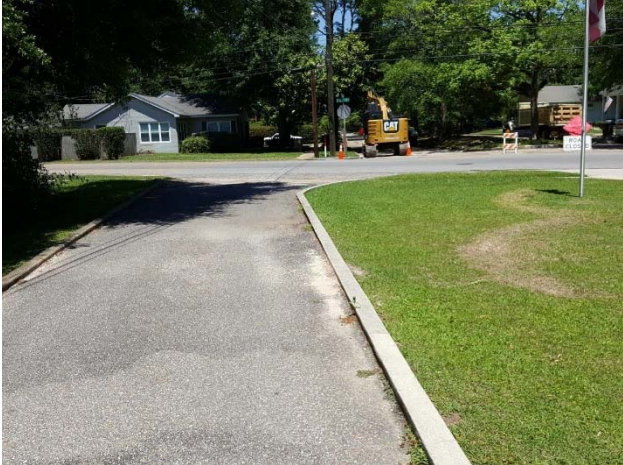
| <p>1. Parking areas at the south of the property and the access drive serving the parking area is paved with asphalt.</p> | <p>2. The drive serving the fire truck bay is paved with concrete.</p> |

| NO. | SECTION # | DESCRIPTION | QUANTITY | UNIT | UNIT COST | OPINIONS OF COST | Deficiency Photo |
|---|---|---|---|---|---|---|---|
| 1 | | <b>Repair Asphalt Pavement Potholes</b><br>Excavate potholes and cavitated areas including pavement removal in affected parking and entrance drive areas . Backfill and compact with clean structural fill. | 3 | MD | \$350.00 | \$1,050 | |

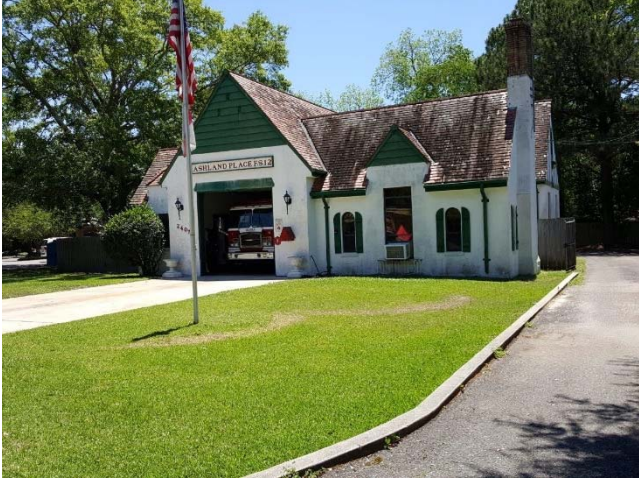
| <p>3. Front elevation of the Subject.</p> | <p>4. The fire truck bay area is provided with an overhead on the north elevation side.</p> |

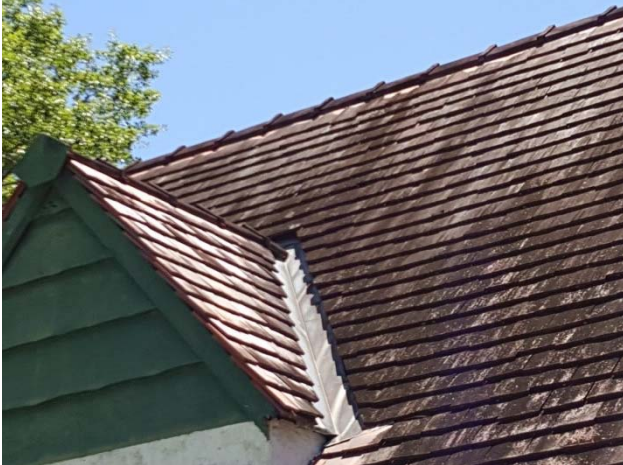
| <p>5. The roofs are pitched and consists of terracotta tiles.</p> | <p>6. Roof is drained by a system of gutters and leaders.</p> |

| NO. | SECTION # | DESCRIPTION | QUANTITY | UNIT | UNIT COST | OPINIONS OF COST | Deficiency Photo |
|---|---|---|---|---|---|---|---|
| 7 | | <b>Roof Replacement Budget</b><br>The clay tile attachment system, underlayment and flashings have exceeded their EUL and replacement or restoration of the system is required. CBRE has included an estimate for replacement of the system with a similar clay tile system (Ludowici). The system may be able to be restored using the existing tiles. However and full scope of work has not yet been determined. | 4,000 | SF | \$38.00 | \$152,000 | |

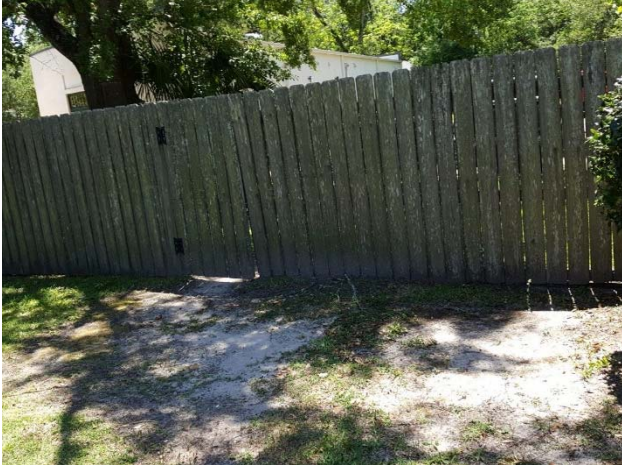
| <p>7. Wood stockade fencing is provided along the property perimeter.</p> | <p>8. Dormitory interior finishes and condition.</p> |

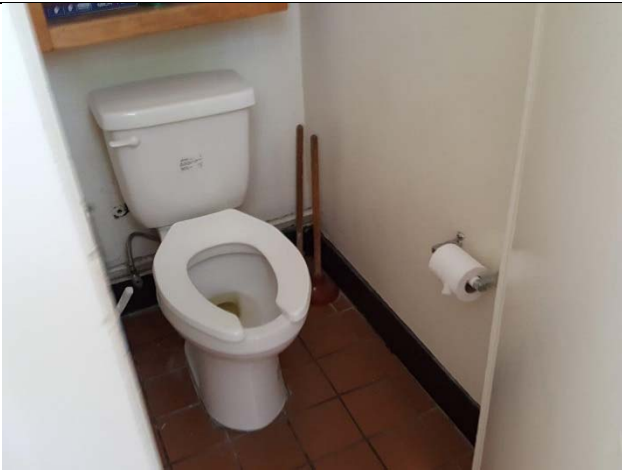
| <p>9. Toilet room interior fixtures and finishes.</p> | <p>10. Kitchen fixtures and finishes.</p> |

| NO. | SECTION NO. | DESCRIPTION | QUANTITY | UNIT | UNIT COST | OPINIONS OF ADA COST | Deficiency Photo |
|---|---|---|---|---|---|---|---|
| 3 | | <b>Create Accessible Toilet</b><br>The Subject's toilet room presently does not meet the minimum ADA requirements including access, fixture configuration and clearances. At this time we recommend the existing toilet room be reconfigured to allow access by persons with disabilities. | 1 | ALLOW | \$10,000.00 | \$10,000 | |

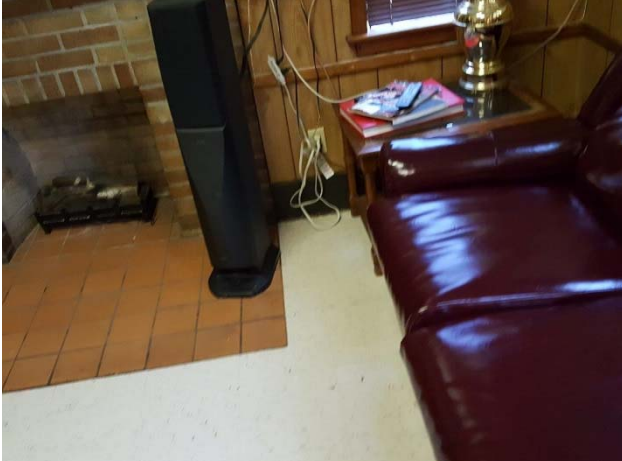
| <p>11. Living room interior finishes and condition.</p> | <p>12. Domestic hot water is generated by a gas fired water heater.</p> |

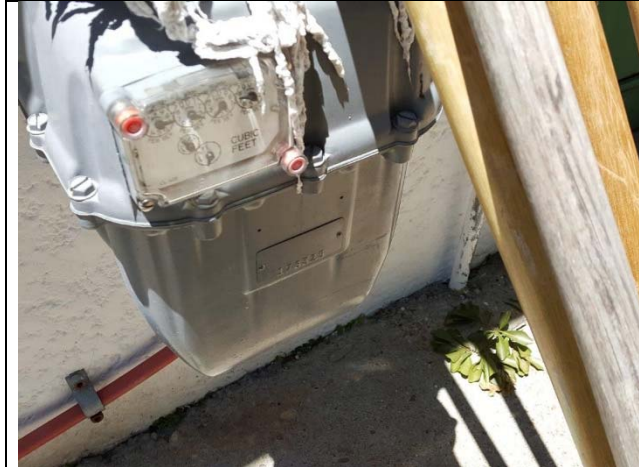
13. Incoming main gas service/meter is located at the southeast building corner.

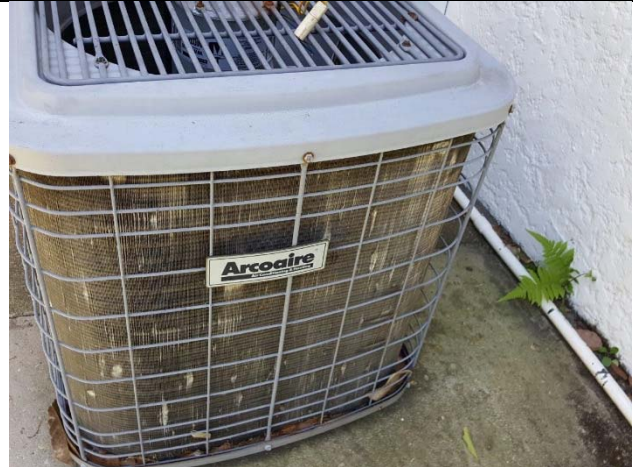
14. Air conditioning and heating is provided by a split-system with the condensers located outside the building.

| NO. | SECTION # | DESCRIPTION | QUANTITY | UNIT | UNIT COST | OPINIONS OF COST | Deficiency Photo |
|---|---|---|---|---|---|---|---|
| 11 | | <b>Supplement Central A/C System</b><br>The current system is inadequate in capacity to properly serve the interiors of the buildings. Based on an industry standard of providing 1-ton of conditioned air for every 350-sf of habitable area, the total system capacity should be approximately 3-tons. The current system is approximately 1.5 tons. At this time, we recommend adding another split system condenser and AHU. A mechanical contractor should review the current living arrangements and provide a suitable system. Based on the layout of the building, it may be possible to replace the system with an interior wall mounted AHU and exterior pad mounted condenser system. | 2 | Ton | \$2,000.00 | \$4,000 | |

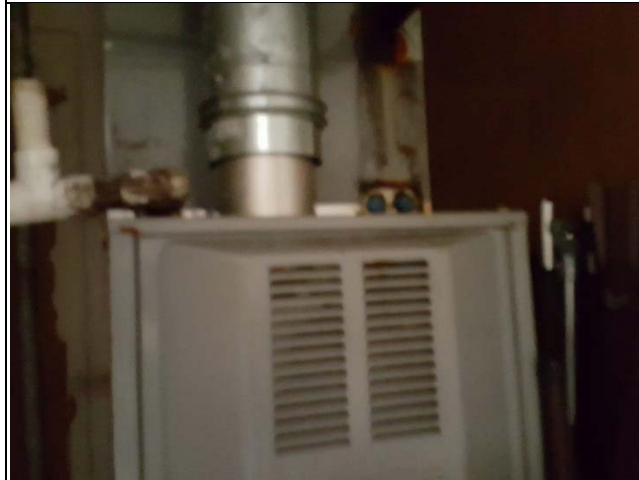
15. The AHU is located in a mechanical closet.

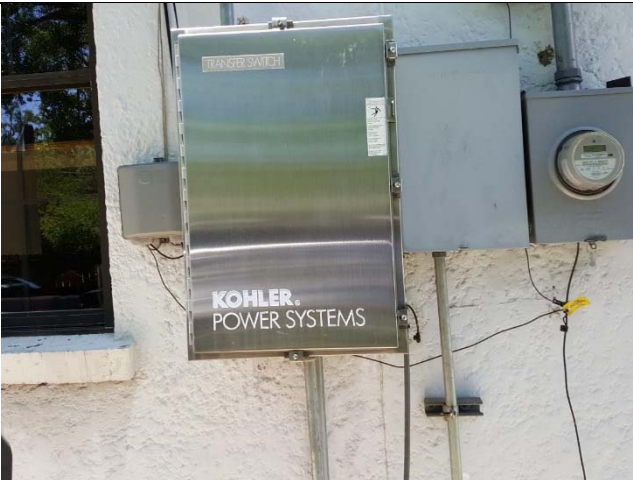
16. The main service panel disconnect switch, transfer switch, and meter are located on the east elevation.

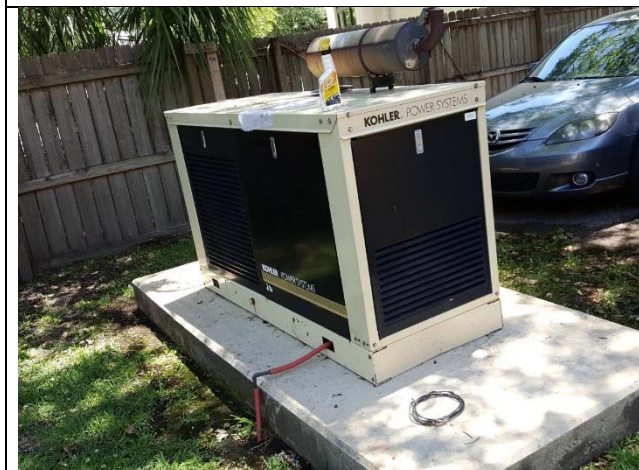
17. The Subject is provided with gas fired emergency generator.

| NO. | SECTION # | DESCRIPTION | QUANTITY | UNIT | UNIT COST | OPINIONS OF COST | Deficiency Photo |
|---|---|---|---|---|---|---|---|
| 13 | | <b>Test Emergency Generator</b><br>We recommend that a full load bank load test be performed for a 2 hour period and that all run sheets be submitted. We further recommend that a maintenance contract be obtained and a log be kept at the set. | 1 | MD | \$750.00 | \$750 | |

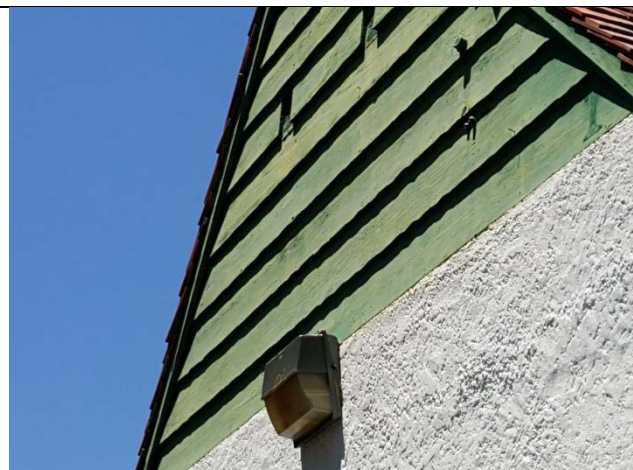
18. Site lighting is provided by building mounted fixtures.

| NO. | SECTION # | DESCRIPTION | QUANTITY | UNIT | UNIT COST | OPINIONS OF COST | Deficiency Photo |
|---|---|---|---|---|---|---|---|
| 15 | | <b>Improve Exterior Site Lighting</b><br>During our survey of the Subject's exterior spaces, especially at the entrances, we noted the existing fixtures to be old with some damaged. We recommend the installation of new high intensity discharge (HID) fixtures by surface mounted on the facades, over the entrances or generally as needed to improve visibility and security. | 6 | EA | \$500.00 | \$3,000 | |
