FACILITY CONDITION ASSESSMENT

City of Mobile

Facility No: 714 - 1

Azalea Road Complex – Buildings 1
and 2 (Classrooms)

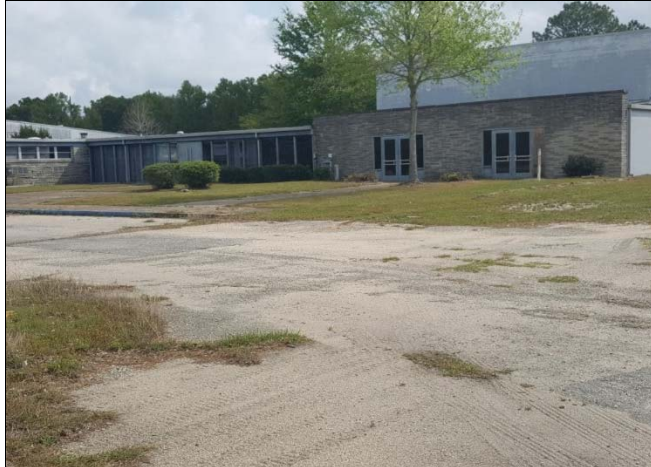
1. The complex is a school that was donated to the City of Mobile in 1994.

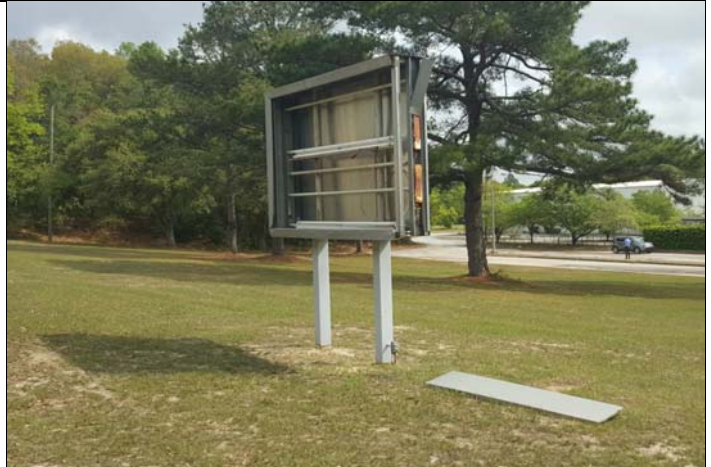
2. The damaged sign located along the front edge of the property.

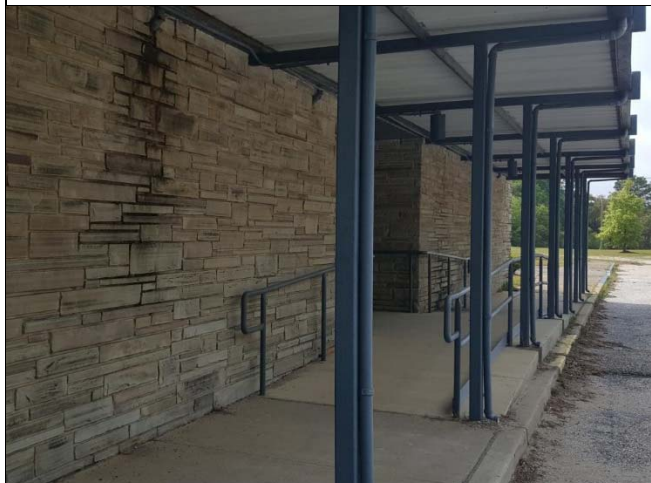
3. There are concrete sidewalks and ramped walkway at the front entrance.

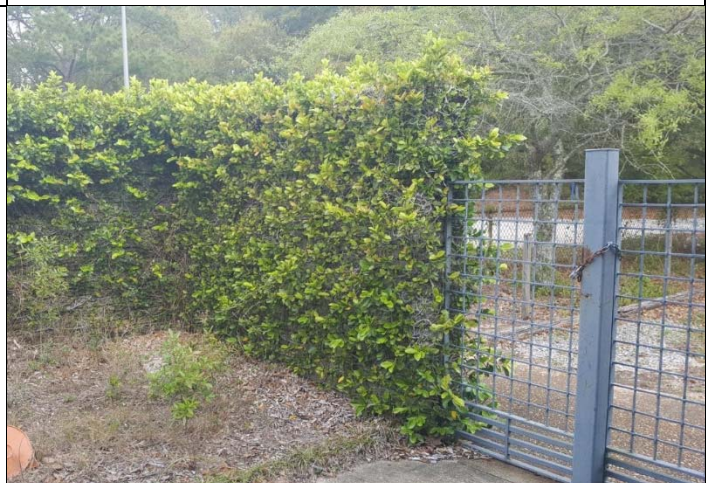
4. A small courtyard area with water feature is enclosed by metal fencing and a masonry covered in vines.

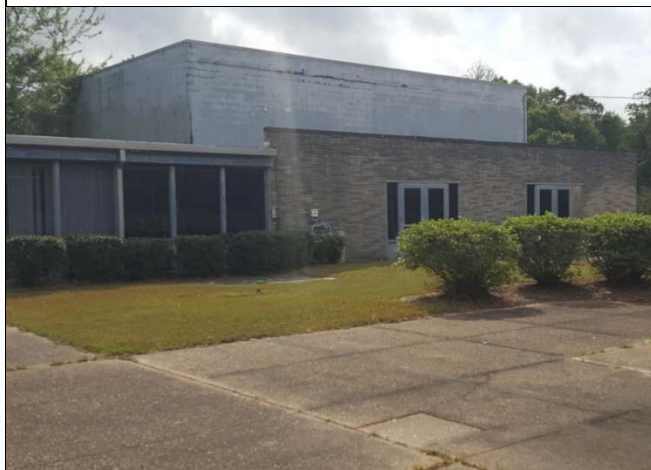
5. The main building is CMU faced with stone on the front elevation.

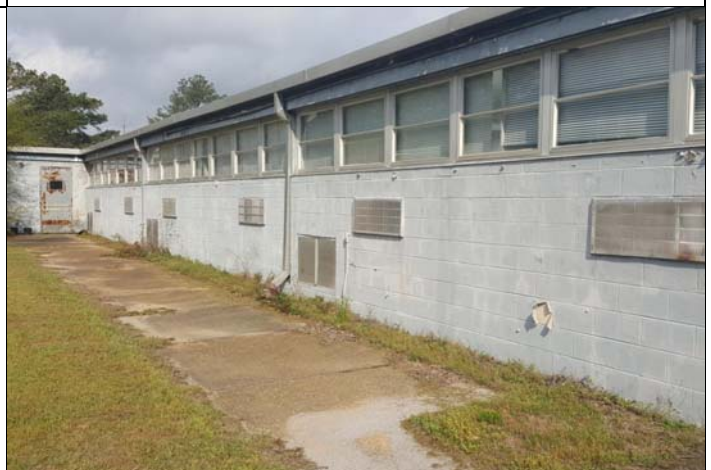
6. The original classroom building is a single story CMU bearing wall supporting steel structure.

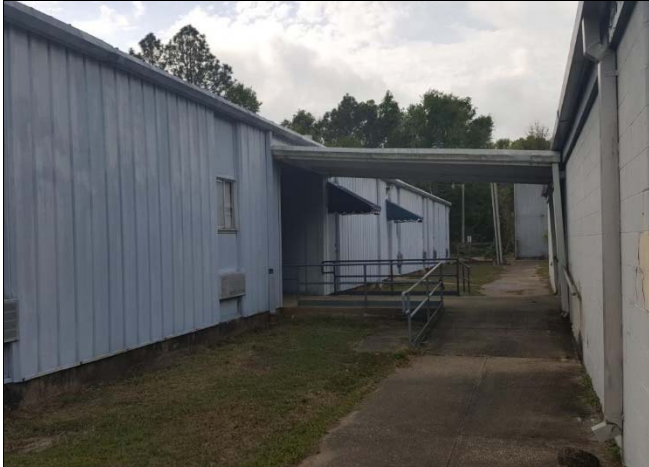
7. Classroom 2 is a pre-manufactured metal building connected by a steel canopy.

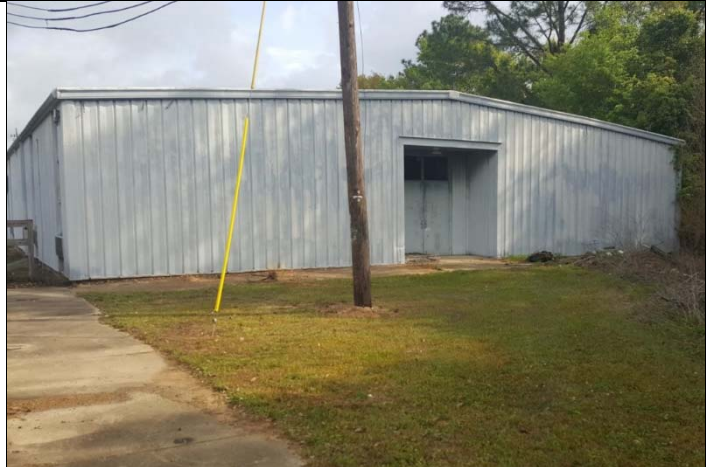
8. Classroom 2 primarily has painted metal panels for the walls and roof.

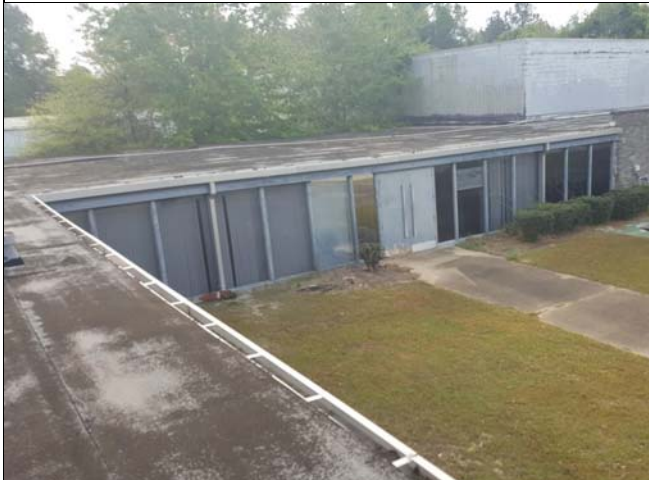
9. The roof over Classroom1 is a BUR that has perimeter downspouts and gutters.

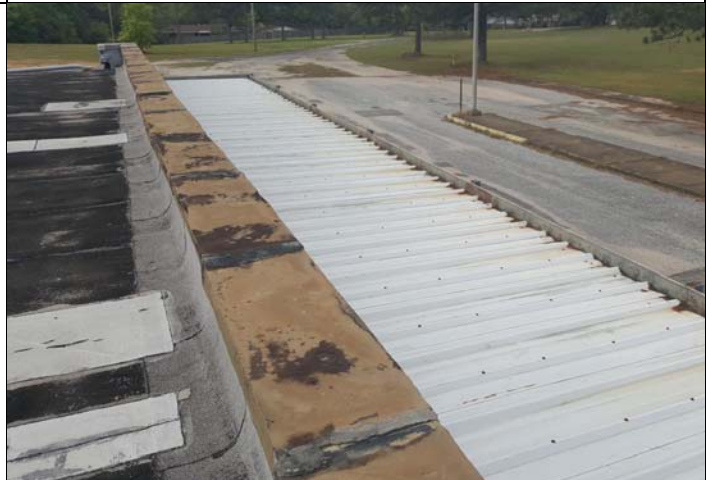
10. The parapet along the front of Classroom 1 has cast stone coping. The canopy is a metal roof structure.

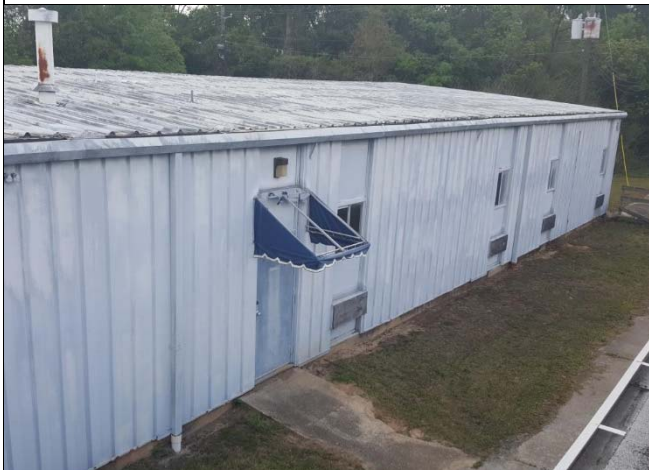
11. Classroom 2 has a low slope metal roof drained by gutters and downspouts.

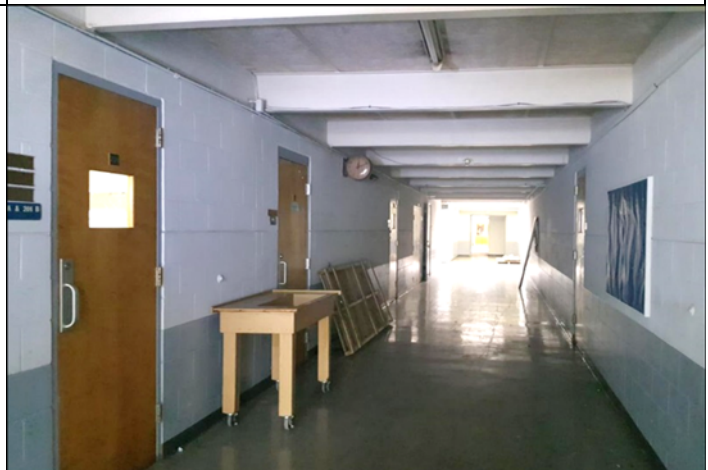
12. Classroom 1 is a T-shaped building with double loaded corridors and classrooms on each side.

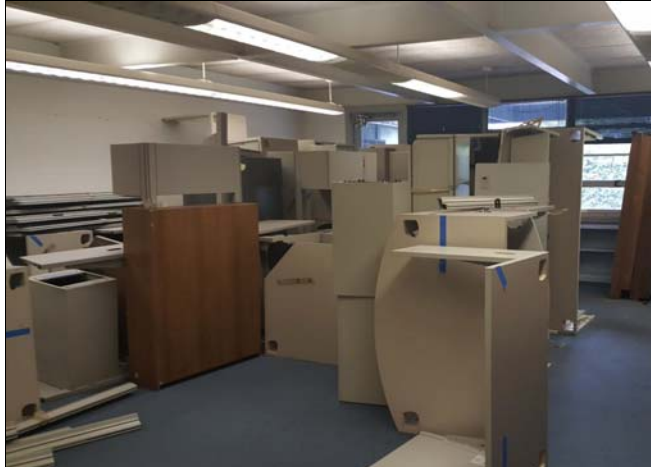
13. Most of the building has been mothballed and is used for storage.

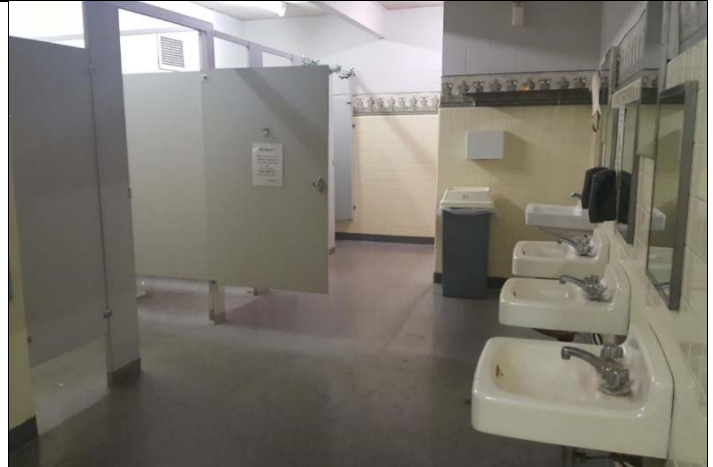
14. Two large multi-user toilets are located in the Classroom 1 building.

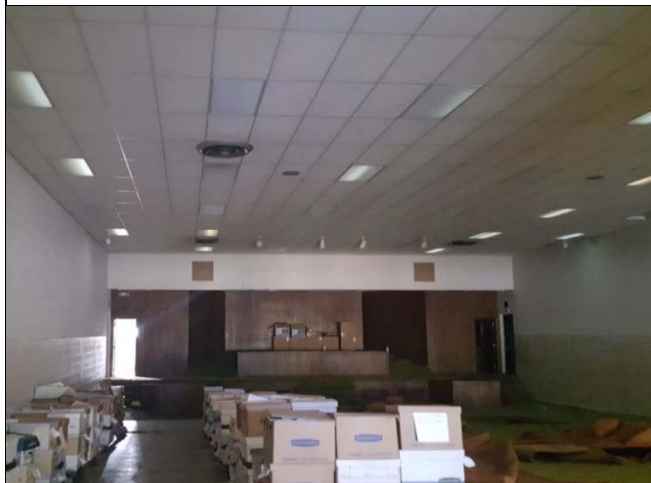
15. The old auditorium is used for file storage of various municipal departments.

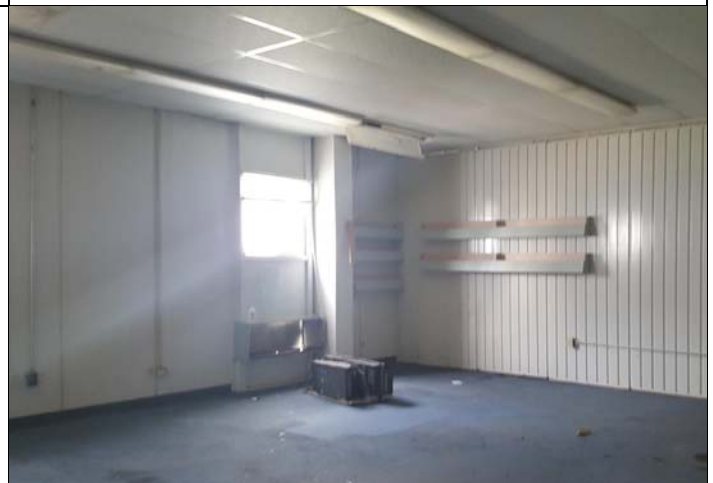
16. Classroom 2 is similar with double loaded corridors and classrooms on each side.

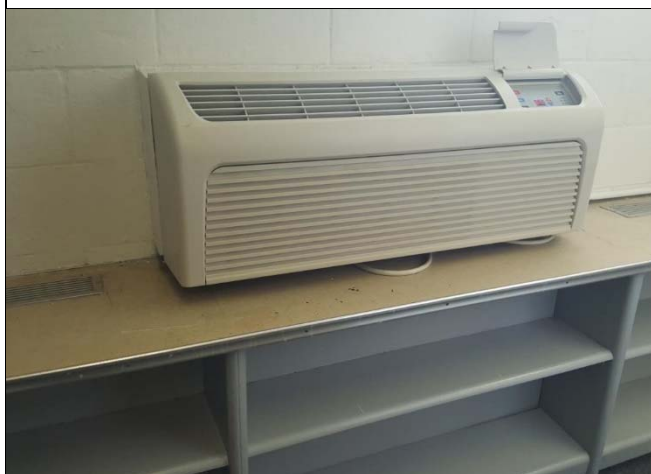
Air conditioning and heating was once provided by a central system with equipment located at the center of the main building. The auditorium has a package unit within a chain link enclosure. The central equipment has primarily been abandoned in place with PTAC units providing the main heating and cooling at the individual spaces. The PTACs range in age and costs have been included to remove the defunct equipment, replace the package unit at the auditorium and replace the PTACs on an on-going basis.

17. The central HVAC system is not used; some spaces utilize PTAC units.

3.6	PLUMBING SYSTEMS						
		No Items				\$0		
		Subtotal Plumbing Systems				\$0		
	3.7	HEATING, VENTILATION & AIR CONDITIONING						
10		Remove Existing Defunct HVAC Equipment The central HVAC system is not in use. Currently, heating and cooling is provided by individual PTAC units at the individual rooms. Although the HVAC system is not in operation, and budget should be established to inspect equipment, remove debris, lubricate valves and moving parts, adjust belts, and evaluation switches and controls, among other items.	1	LS	\$20,000.00	\$20,000

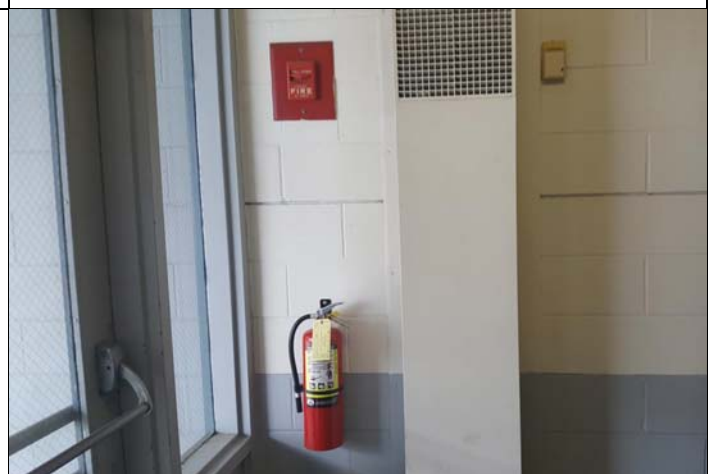
The building is not provided with a sprinkler system but has fire alarm pulls, smoke detectors and fire extinguishers. Fire extinguishers were last inspected in 2014 and were observed to have expired. Fire protection is also provided by a fire alarm panel manufactured by DMP connected to the various devices. Observed devices consist of smoke detectors, A/V devices, emergency lighting, illuminated exit signage and pull stations.

18. The buildings have fire alarm pull stations and fire extinguishers along the egress routes.

3.9		FIRE PROTECTION AND LIFE SAFETY						
13		Pressure Test and Re-Tag Fire Extinguishers The on-site fire extinguishers were found to have expired inspection tags. Each fire extinguisher should be pressure tested, re-charged (if needed) and re-tagged.	8	EA	\$100.00		\$800
