FACILITY CONDITION ASSESSMENT

City of Mobile

Civic Center Arena

Project No. PC60828394 - 201

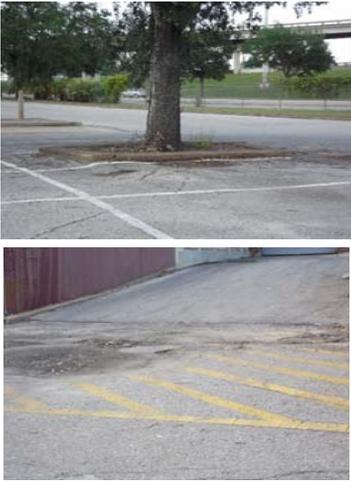
NO.	SECTION #	DESCRIPTION	QUANTITY	UNIT	UNIT COST	OPINIONS OF COST SHORT TERM	Deficiency Photo
		SITE					
1		<p>Full Depth Asphalt Pavement Replacement ^ ^ The age of the asphalt paving is unknown but advanced. Deficiencies include faded striping, scattered cracks, root damage around tree wells including the curbing, potholes, numerous previously patched areas and past trenched areas, and eroded fines throughout. The paving has exceeded its EUL and many of the other site repairs are expected to require parking lot excavation. Full depth asphalt paving replacement and re-striping will be required in conjunction with other site repairs including areas of curbing replacement and replacement and rewiring of site lighting throughout the complex in the short term, and ongoing pavement maintenance will be required during the reserve term.</p>	479,000	SF	\$3.50	\$1,140,020

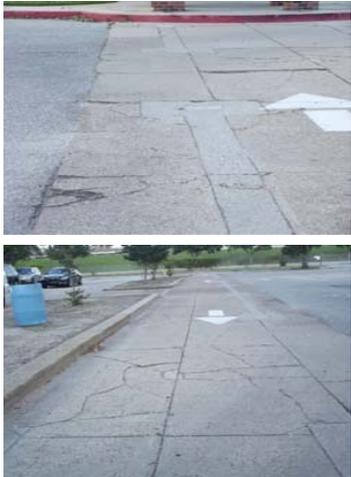
2		<p>Concrete Pavement ^ ^ Concrete paving at the covered pedestrian walkways that extend into the parking lot is encumbered with numerous cracks and broken areas. Additionally, the sidewalk at the Theatre curbside loading area is cracked and breaking up; most probably as a result of vehicular traffic using the sidewalk as a driveway/loading platform. The affected flatwork should be removed and replaced with new concrete paving with a paving section appropriate for vehicular traffic. Provide compressible pre-molded expansion joints between existing and old flatwork and every 20 LF of paving.</p>	5,000	SF	\$25.00	\$85,000

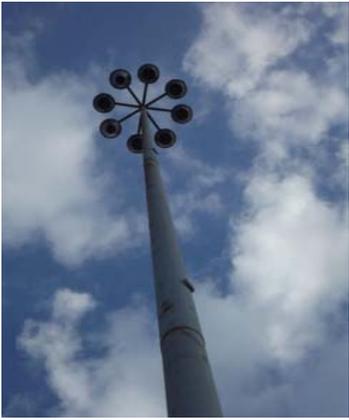
NO.	SECTION #	DESCRIPTION	QUANTITY	UNIT	UNIT COST	OPINIONS OF COST SHORT TERM	Deficiency Photo
6		<p>Replace Lighting Standards, 45'-60' ^ ^ Lighting standards are 53 years old, at the end of their EUL's, and in poor condition with many that are inoperable. Deficiencies include failed underground wiring, deteriorated protective finish coatings and obsolete lamping. Lighting standards and underground wiring should be replaced.</p>	11	EA	\$10,000.00	\$74,800

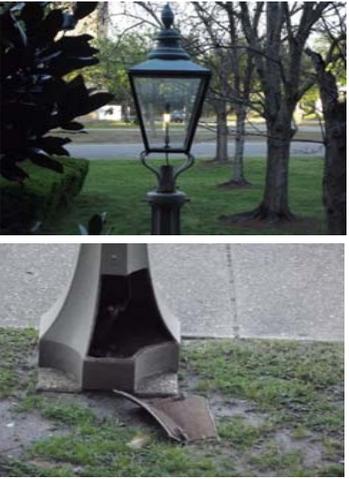
7		<p>Refurbish Decorative Gas Lighting ^ ^ Decorative gas lighting standards are of unknown but advanced age and the finish at the standards has failed. The decorative lighting standards should be refurbished.</p>	34	EA	2,500	\$57,800

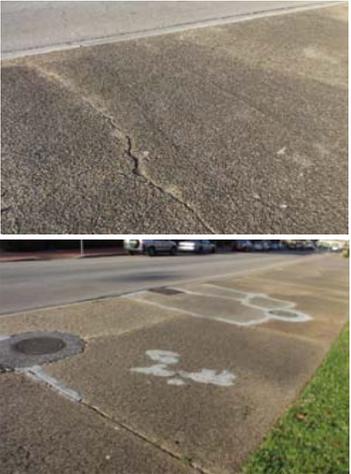
NO.	SECTION #	DESCRIPTION	QUANTITY	UNIT	UNIT COST	OPINIONS OF COST SHORT TERM	Deficiency Photo
11		<p>Replace Concrete Sidewalk Sections (25%) ^ ^ Much of the concrete sidewalk throughout the complex is believed to date from the original construction, is encumbered with eroded fines, and is encumbered with cracks and deterioration. Remove deteriorated sections, prepare bed, and install new 4" thick sidewalks. Sidewalk sections that exhibit cracks but that do not warrant replacement should have all cracks pointed with a non-shrinking grout.</p>	20,900	SF	\$15.00	\$213,180

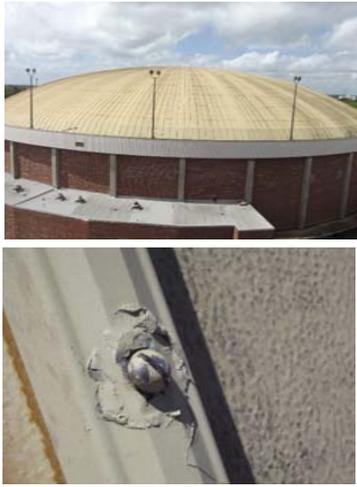
NO.	SECTION #	DESCRIPTION	QUANTITY	UNIT	UNIT COST	OPINIONS OF COST SHORT TERM	Deficiency Photo
35		<p>Refurbish Standing Seam Metal Dome Roof</p> <p>The highly visible 50+ year old standing seam metal dome roof is stained, discolored, has some scatter punctures and the mechanical fasteners are backing out of the system. The roof has reached the end of its EUL and replacement is recommended at this time. The replacement cost is being provided as an allowance. A study of the roof system is recommended to determine the most cost effective way to approach the roof repair or replacement.</p>	118,000	SF	\$45.00	\$5,310,000

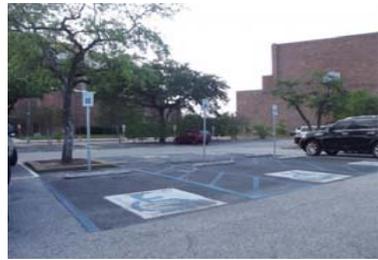
NO.	SECTION NO.	DESCRIPTION	QUANTITY	UNIT	UNIT COST	OPINIONS OF ADA COST	DEFICIENCY PHOTO
	4.5	ADA MODIFICATIONS					
1		<p>ADA Survey</p> <p>During our site survey, we noted that the Subject provides limited handicapped accessibility. The law became effective for existing buildings classified as "Public Accommodations" on January 26, 1992. We recommend that an ADA survey be conducted to identify all barriers and any readily achievable improvements/modifications.</p>	1	LS	\$7,500.00	\$7,500	
2		<p>Re-Stripe ADA Parking Spaces</p> <p>The number of standard sized accessible parking spaces provided is slightly above requirements, however striping is faded and illegible and many of the spaces provided lack the required 60" side aisle. Re-striping is recommended for all accessible parking spaces and the required side aisles. No cost is provided, as this would be covered as part of the anticipated re-paving project.</p>	15	SPACE	\$250.00	\$0*

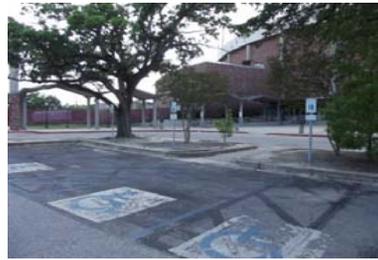
3		<p>Add Handicap Van Parking Spaces</p> <p>A sufficient number of van sized accessible parking spaces with 96" wide side aisles are provided, however striping at the existing spaces is faded and illegible. Re-striping is recommended to add an additional van accessible space and re-strip existing van spaces. No cost is provided, as this would be covered as part of the anticipated re-paving project.</p>	2	Each	\$250.00	\$0*

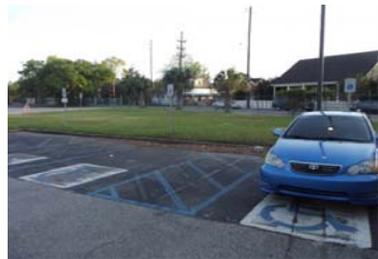
NO.	SECTION NO.	DESCRIPTION	QUANTITY	UNIT	UNIT COST	OPINIONS OF ADA COST	DEFICIENCY PHOTO
4		<p>Install Accessible Parking Stall Signage The Subject was found to be fitted with an adequate number of handicapped accessible parking stalls and van stalls but a few stalls share common signs and each stall is presently not equipped with an individual posted sign. According to ADAAG, each handicapped accessible parking stall should be marked with both pavement striping and international symbol and a posted sign mounted directly in front of the stall. All colors should be contrasting.</p>	2	EA	\$150.00	\$300

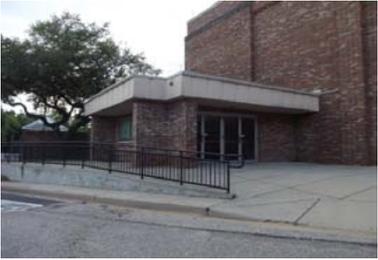
NO.	SECTION NO.	DESCRIPTION	QUANTITY	UNIT	UNIT COST	OPINIONS OF ADA COST	DEFICIENCY PHOTO
7		<p>Install Detectable Warnings at Walkways While on-site, several locations requiring detectable warning strips or textures were noted. Specifically this condition was noted at the curb cut on the south side of the Expo Hall, and outside the south entrances to the Arena. These devices/surfaces will aid in alerting a blind pedestrian of a walkway end/change of direction, ramps or other hazardous area.</p>	40	SF	\$25.00	\$1,000

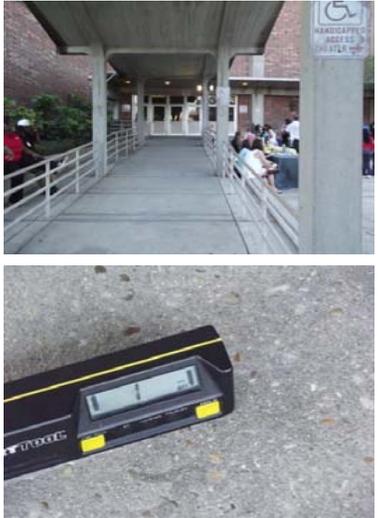
NO.	SECTION NO.	DESCRIPTION	QUANTITY	UNIT	UNIT COST	OPINIONS OF ADA COST	DEFICIENCY PHOTO
9		<p>Repave Concrete Ramp to Shallower Slope **</p> <p>Presently, spot checks at the concrete ramp at the southeast Arena entrance found slopes of 7/8" to 1" per foot. Technically, this exceeds the ADA allowable 1:12 (3/4" per foot) but may be considered nominally compliant. Scope of work for technical compliance would include removal of existing pavement/handrails, repaving of concrete ramp and installation of handrails. No cost is included as this is advisory only.</p>	125	LF	\$117.00	\$0 **

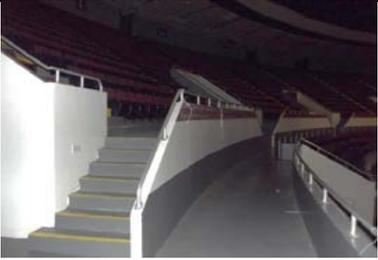
10		<p>Create Accessible Auditorium Seating</p> <p>The Subject includes a common-use assembly area with fixed seating, accessible seating is limited to approximately 22 wheelchair spaces above the stage at the south side of the arena. Based on 6,120 fixed seats, ADA requires a total of 63 accessible seats. We recommend creating additional accessible seating by removal of fixed seating to be replaced with level seating areas for wheelchairs. This work may require modification of some of the concrete guardrails around the main perimeter aisle. Scope of the work includes removal of chair, cast in place concrete, and signage.</p>	41	EA	\$360.00	\$14,760

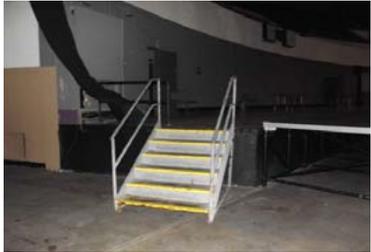
NO.	SECTION NO.	DESCRIPTION	QUANTITY	UNIT	UNIT COST	OPINIONS OF ADA COST	DEFICIENCY PHOTO
11		<p>Install Interior Wheelchair Lift</p> <p>The arena stage area requires several steps up for access so is not currently accessible. Installation of an interior hydraulic lift at this location could provide full compliance.</p>	1	EA	\$15,000.00	\$15,000

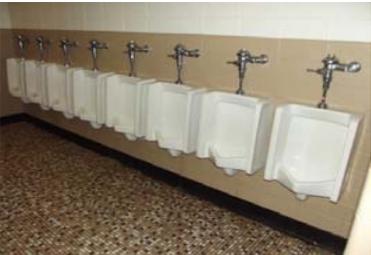
12		<p>Assistive Listening System (Magnetic Induction Loop)</p> <p>Presently, areas within the Subject where audible information is integral to the use of the space are not equipped with an adequate number of assistive listening devices. We recommend installation of a magnetic induction loop assistive listening system in these areas.</p>	1	EA	\$6,000.00	\$6,000	Not Currently Provided
13		<p>Lower Urinal for Handicapped Access</p> <p>At present, the common toilet rooms are equipped with only standard mounting height wall urinals without grab bars. One (1) urinal should be lowered or removed and replaced with a lower mounted wall urinal to provide handicapped access. Installation should include grab bars and patching of all affected wall surfaces during installation. No cost is provided as this item would be covered in the toilet room renovation budget.</p>	4	EA	\$1,700.00	\$0 ^

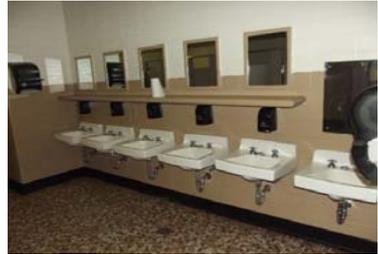
NO.	SECTION NO.	DESCRIPTION	QUANTITY	UNIT	UNIT COST	OPINIONS OF ADA COST	DEFICIENCY PHOTO
14		<p>Install New ADA Sink The common toilet rooms are equipped with standard height sinks which do not allow easy roll-up access. One (1) of the sinks should be lowered or replaced with an ADA compatible sink with paddle faucet, shelf and tilted mirror. No cost is provided as this item would be covered in the toilet room renovation budget.</p>	8	EA	\$2,500.00	\$0 ^

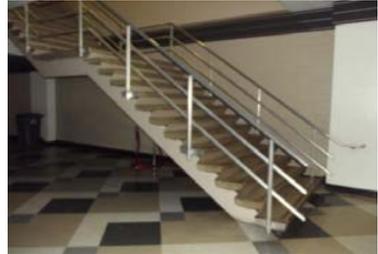
15		<p>Install Under-Stair Barrier Installation of an under-stair barrier is required under the staircase located at the southeast concourse. ADA requirements state that a barrier must be placed before headroom is less than 80". We recommend placing a 4'x4'x2' square wood planter.</p>	1	EA	\$1,500.00	\$1,500

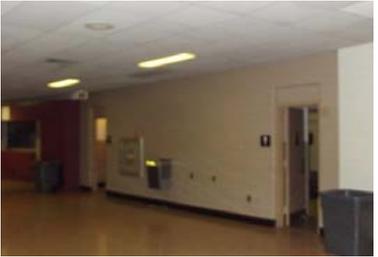
NO.	SECTION NO.	DESCRIPTION	QUANTITY	UNIT	UNIT COST	OPINIONS OF ADA COST	DEFICIENCY PHOTO
18		<p>Installation ADA Compliant Drinking Fountains Existing drinking fountains are not ADA compliant. Where drinking fountains are provided, the ADA recommends having approximately half are low fountains for wheelchair accessibility and the other half mounted at standing height.</p>	4	EA	\$3,200.00	\$12,800
