FACILITY CONDITION ASSESSMENT

NTP-PL220-16

Tricksey Senior Center

Project No. PC60828394 - 584

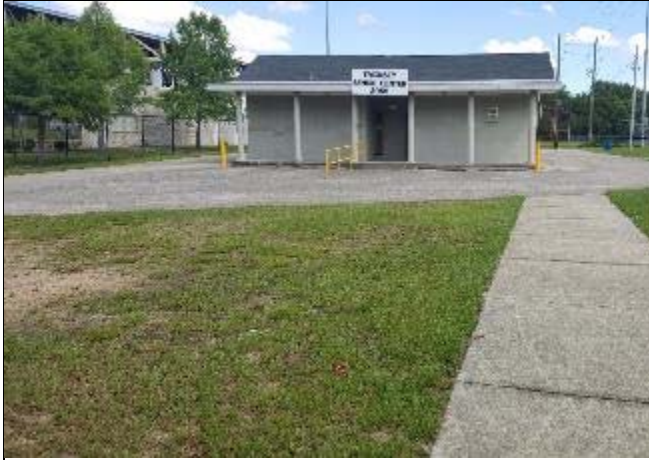
1. The building is a single story structure accessed by an asphalt drive and concrete sidewalks. A ramp system with metal railings is provided at the front entrance.

3		<p>Remove Railing and Install Compliant Ramp</p> <p>A railing was recently installed at the front door. The railing impedes traffic and the ramp appears to lack the appropriate side flare with cross slope requirement. Remove railing and install appropriate ramp. Railing can be installed along the side of the walls for convenience for the seniors.</p>	1	LS	\$5,000.00	\$5,000

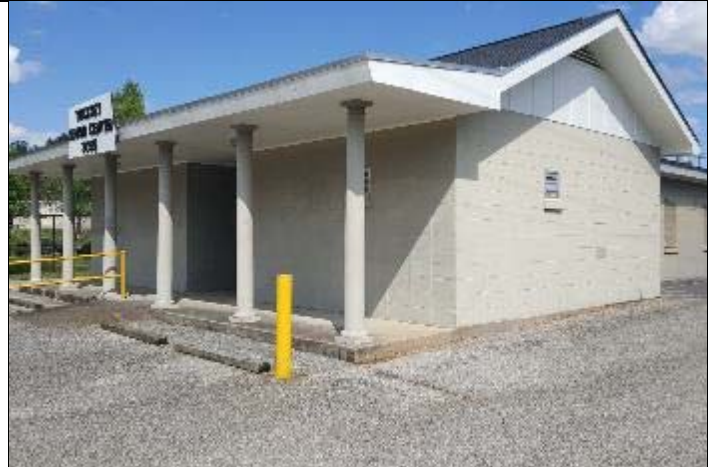
2. The exterior wall is painted CMU, which is a bearing wall supporting the wood structure.

3.2	STRUCTURAL SYSTEM						
		No Items Required					\$0	
		Subtotal Structural System					\$0	
	3.3	EXTERIORS						
1		Repaint Exterior Walls The exterior CMU walls are chalky with patchy areas. Scrape, prime and repaint at this time.	3,000	SF	\$1.50		\$4,500	 
2		Wire Brush & Re-Paint Front Door The front door into the facility is a steel door with side lights protected by wire mesh. Rusting was in evidence on the door, mesh and side lights. Wire brush and remove all loose rust and paint (verify absence of lead based paint), and apply primer and 2-coats of a paint coating.	2	MD	\$350.00		\$700	 
		Subtotal Exteriors					\$5,200

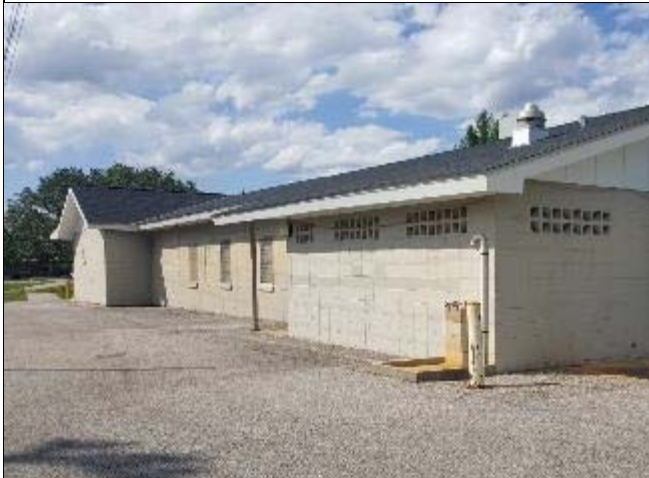
3. The west elevation is homogenous with the other sides of the building.

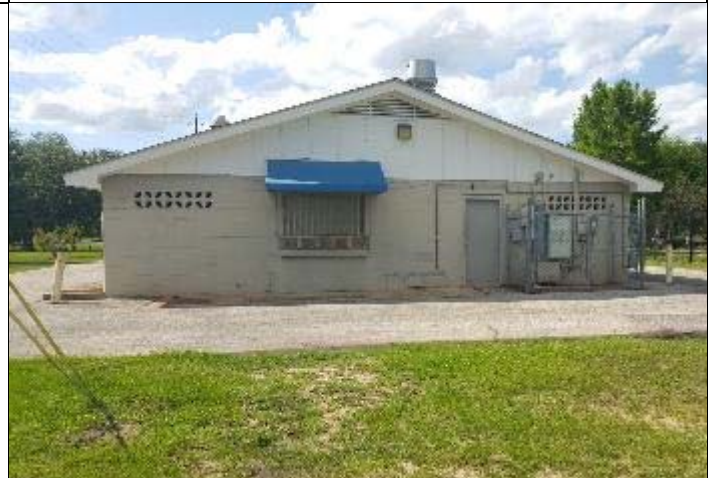
4. The rear elevation of the building has a window with a fabric awning and the electrical service.

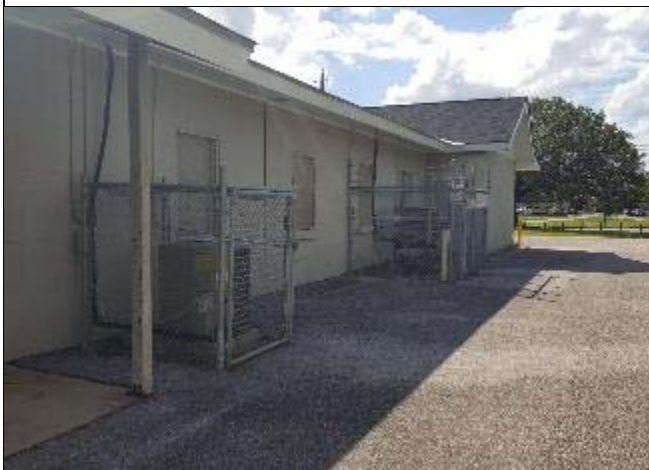
5. The east elevation has two condensers enclosed by chain link fencing.

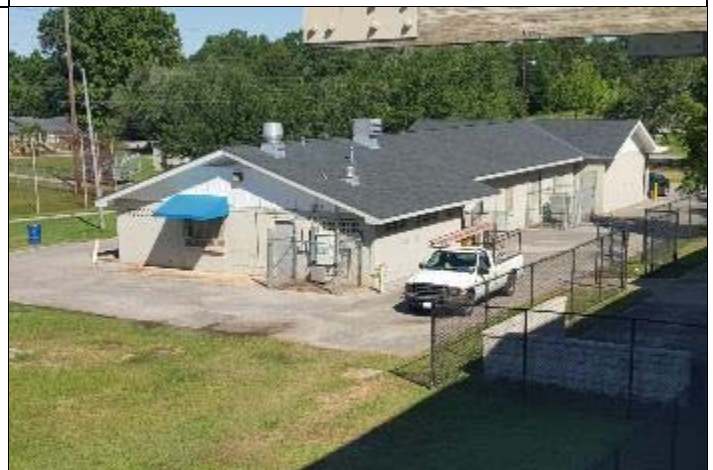
6. The roof is asphalt shingles reportedly about 1 year old.

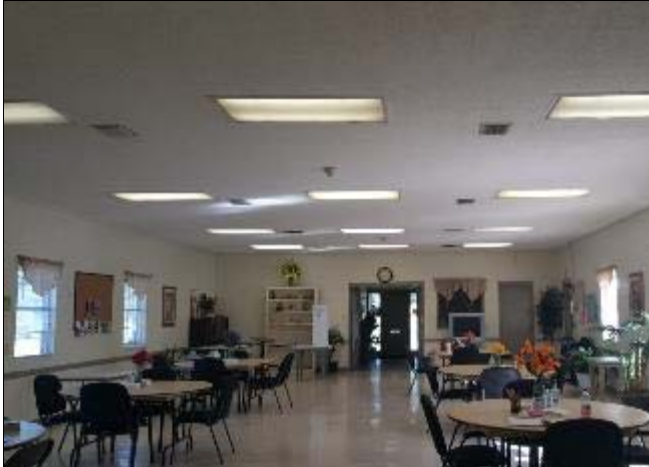
7. The primary space is a multipurpose space for meeting, art and crafts and dining.

3.4	ROOFING						
		No Items Required					\$0	
		Subtotal Roofing					\$0	
	3.5	INTERIORS						
3		Refurbish Main Senior Center Area The interior areas are exhibits flaking paint and missing rubber base. Repaint all walls and repair all interior finishes.	400	SF	\$2.00		\$800	 
		Subtotal Interiors					\$800

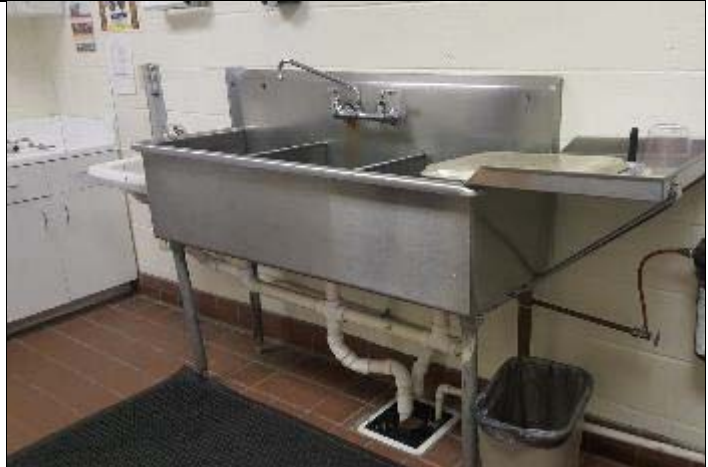
8. A small warming kitchen is located at the rear of the building.

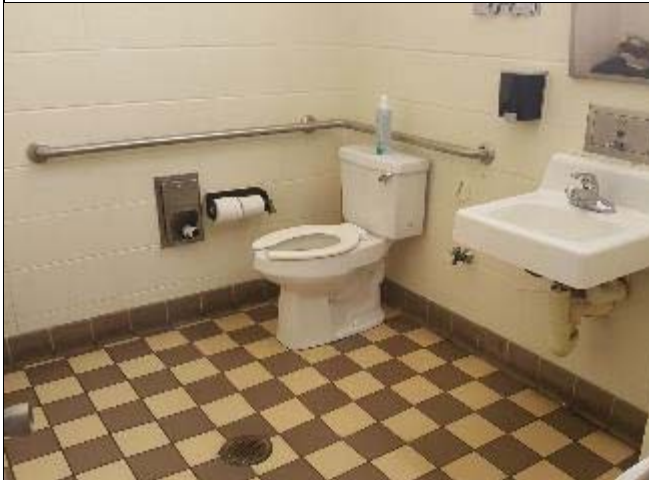
9. Two single user toilet rooms are provided for the senior center.

2		<p>Provide Correct Hardware at Single User Toilets - Senior Center</p> <p>The doors into the single user toilets at the senior center were noted to have knob hardware. Replace with lever hardware at this time.</p>	2	EA	\$250.00	\$500

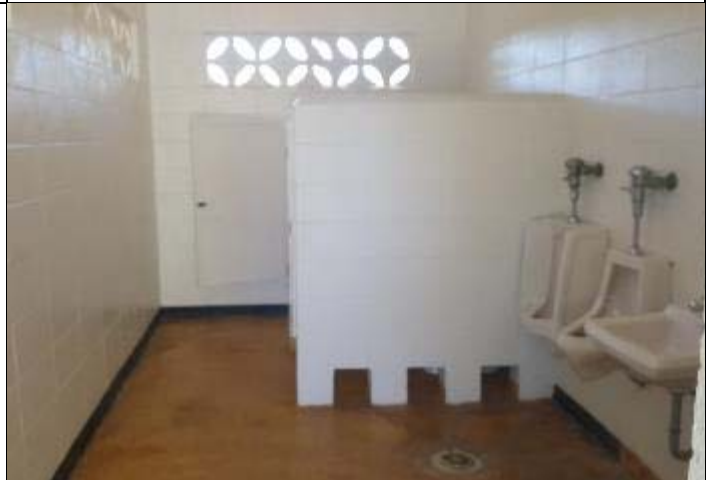
10. Two multi-user toilet rooms are accessed from the exterior to support the ball fields.

NO.	SECTION NO.	DESCRIPTION	QUANTITY	UNIT	UNIT COST	OPINIONS OF ADA COST	Deficiency Photo
	4.5	ADA MODIFICATIONS					
1		<p>Modify Existing Multi-User Toilets</p> <p>The existing restrooms are not presently fully accessible and lack the interior clearances necessary. Deficiencies include lack of required clearances at fixtures and toilet stalls, door clearances, hardware, and signage, grab bars, undersink insulation, and mounting heights for fixtures and toilet accessories that are outside compliant ranges. It appears that the existing space could be modified to accommodate at least one accessible stall in each of the multi-user toilet rooms.</p>	2	EA	\$5,200.00	\$10,400

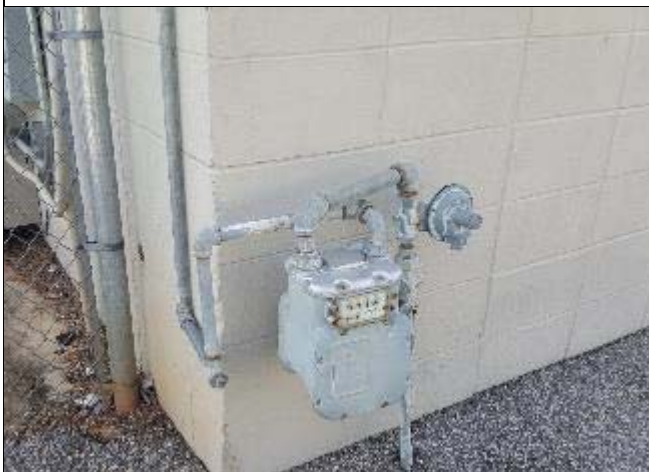
11. A gas meter is located at the southeast corner of the building.

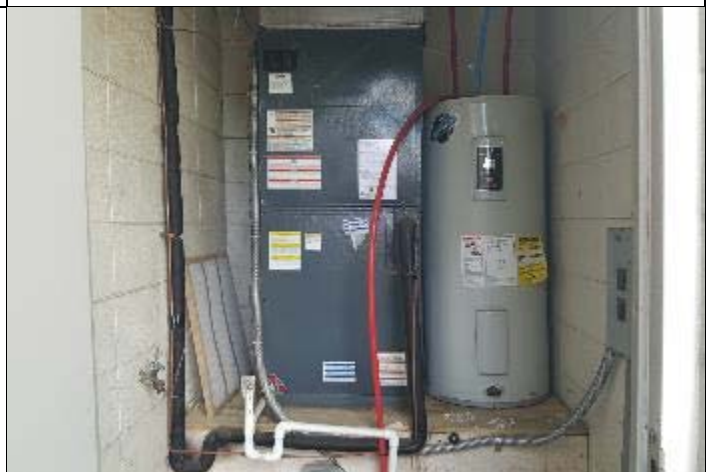
12. The building is heated and cooled by split systems and DWHs provide hot water.

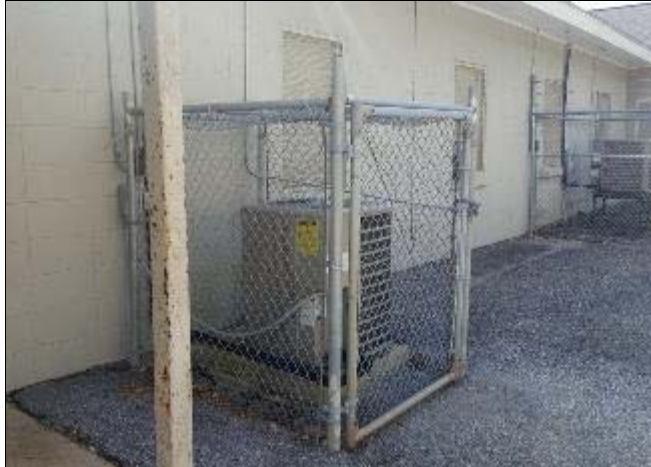
13. Split systems are located at grade in chain link fence enclosures.

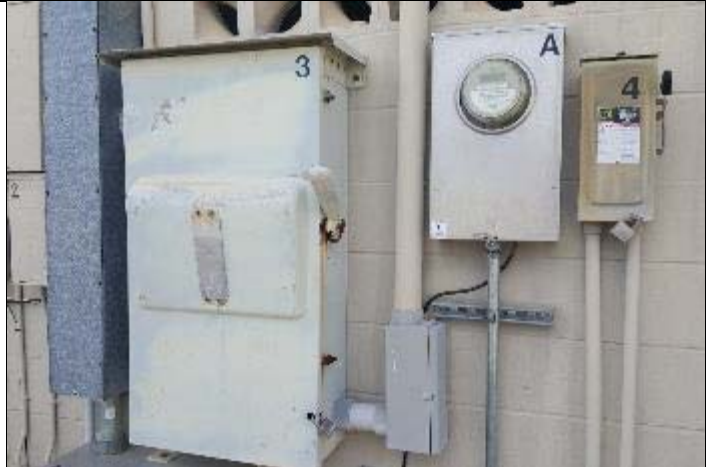
14. The main electrical service enters the Subject into the south side of the building.

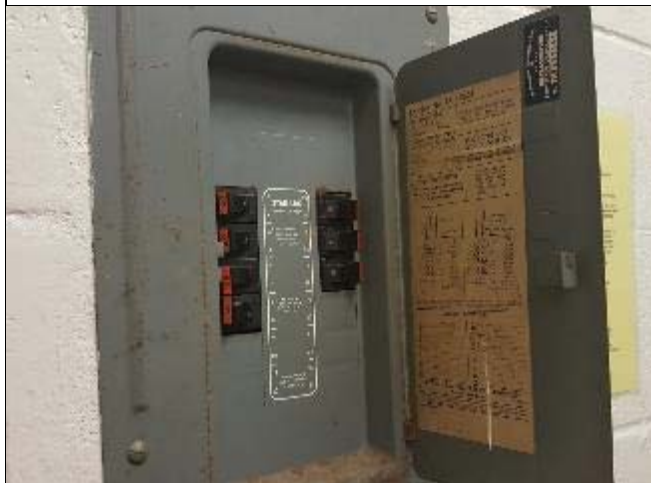
15. Stab Lok distribution panels were observed.

NO.	SECTION #	DESCRIPTION	QUANTITY	UNIT	UNIT COST	OPINIONS OF COST	
						SHORT TERM	Deficiency Photo
	3.8	ELECTRICAL SYSTEM					
4		Replace Stab-Lok Electrical Panels The Subject was found to have federal Stab-Lok electrical panel at the kitchen areas. These panels have been found to exhibit failure potential due to inability to trip in overload conditions, and represent a hazard. Replacement is recommended at this time.	1	EA	\$850.00	\$850

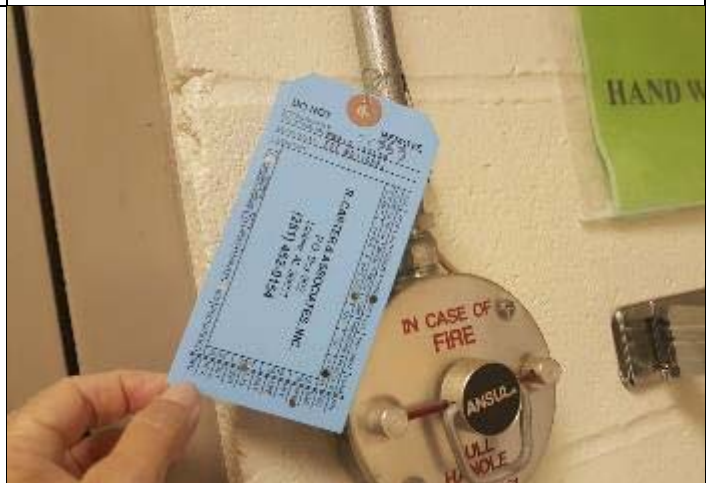
16. The building is not sprinklered, but an ansul system is provided over the stove in the warming area.

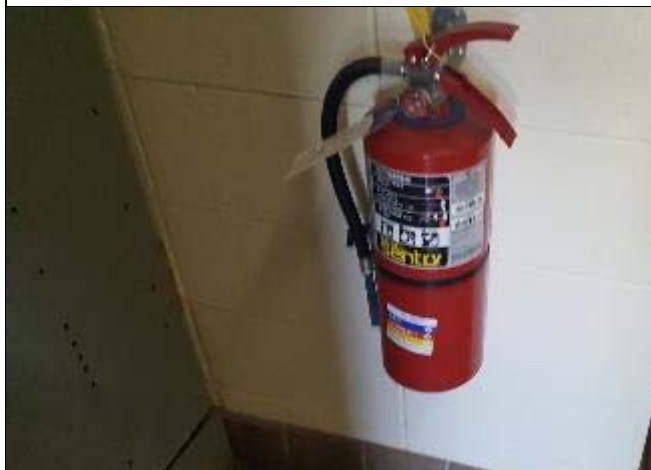
17. A wall mounted fire extinguishers is located at the front vestibule.

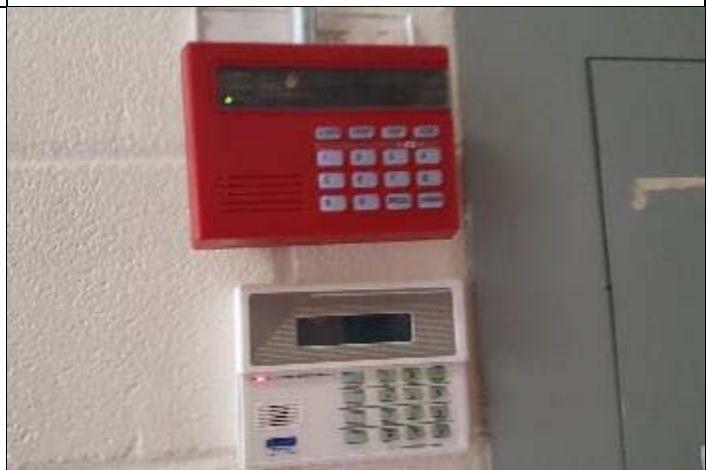
18. A fire alarm and security panel are provided at the front of the facility.
