**CITY OF MOBILE**  
**REQUEST FOR QUOTES**

**Project Name:** Service Repair – Environmental Remediation

**Project Location:** Mobile Police Department Headquarters Building  
2460 Government Blvd.  
Mobile, AL 36606

**Project Number:** SR-009-20

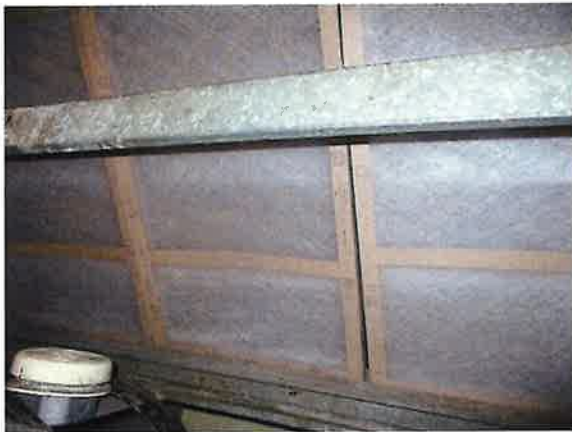
- 2) View of the outside air filter for the heating, ventilation, and air conditioning (HVAC) air handling unit (AHU) in the Former Records Room, on the west side of the first floor. Air sample 2460-2 was collected in this location and was not elevated when compared to the outdoor total fungi concentration.

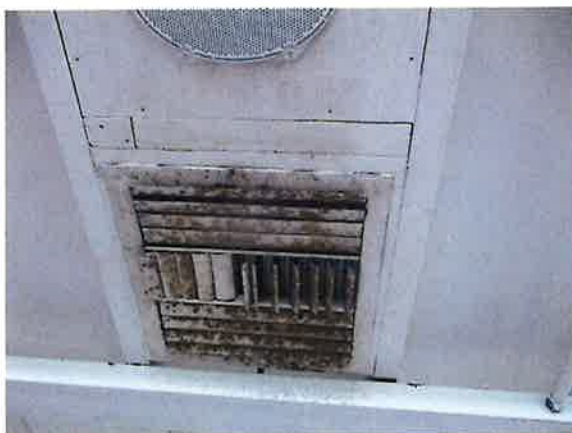
- Visible, suspect mold was observed on chairs and the HVAC supply registers (vents) near the ceiling in Sergeant Sherrod Phillips' Office in the basement.

- 3) View of the supply air diffuser in the ceiling of Sergeant Sherrod Phillips' office located in the basement. Air sample 2460-12 was collected in this location. Air sample 2460-12 was elevated when compared to the outdoor total fungi concentration.

Aerostar identified mold-impacted materials through a visual assessment. Aerostar recommends remediation (removal and/or cleaning) of mold-impacted materials following EPA, IICRC, or other documented methodology. Doors to the exterior of the building should be properly sealed and fully closed. Preventing outdoor air from entering the building aids in the reduction of available moisture in the form of condensation on surfaces where hot and cold air meet. All sources of water intrusion should be eliminated.

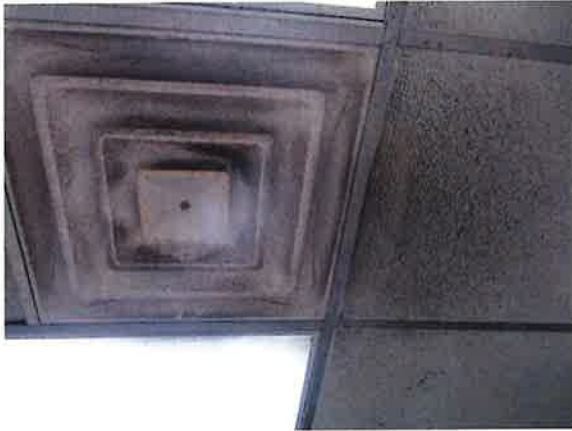
- 4) View of the supply air diffuser in the ceiling of the Property Office Center located in the basement. Air sample 2460-14 was collected in the location and was elevated when compared to the outdoor total fungi concentration.

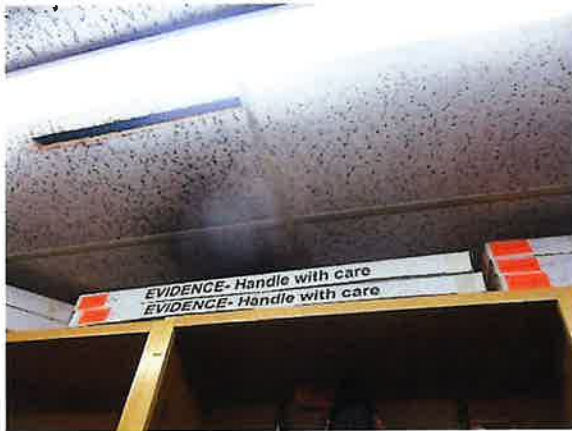
- 5) View of an acoustical ceiling tile (ACT) in the Gun Evidence Storage Area located in the basement. Air sample 2460-17 was collected in this location and was not elevated when compared to the outdoor total fungi concentration.

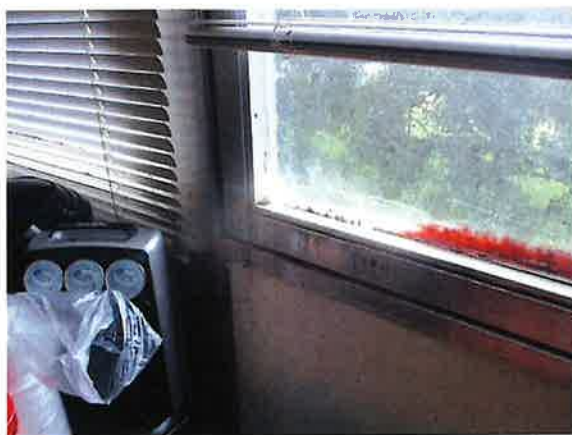
- 6) View of visible, suspect mold on the inside of the window of the Payroll/Personnel Office located on the west side of the second floor. Air sample 2460-23 was collected in this location and was not elevated when compared to the outdoor total fungi concentration.

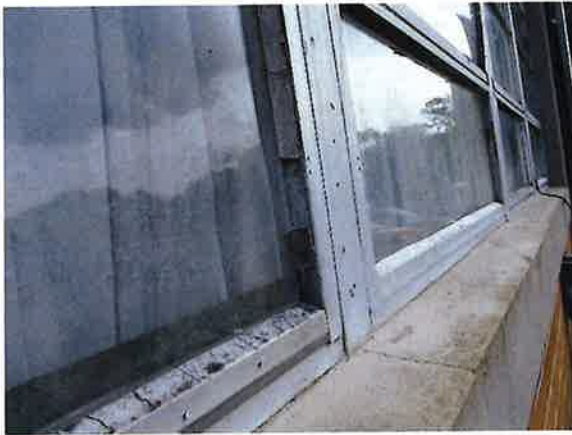
- 7) View of an exterior window pane with missing and damaged caulk located on the east side of the first floor.

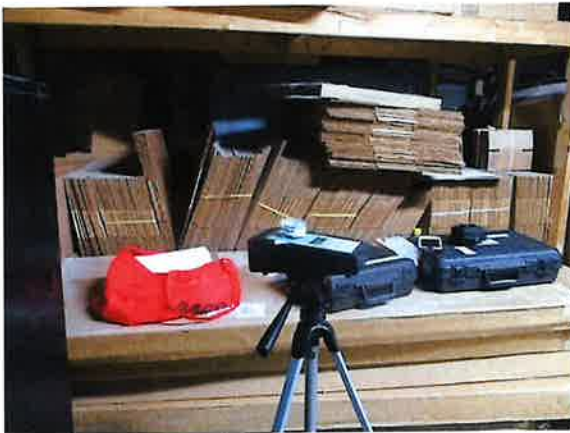
- 8) View of the inside air sample (2460-19) location in the Homicide Evidence Storage Room located in the basement. Air sample 2460-19 was not elevated when compared to the outdoor total fungi concentration.

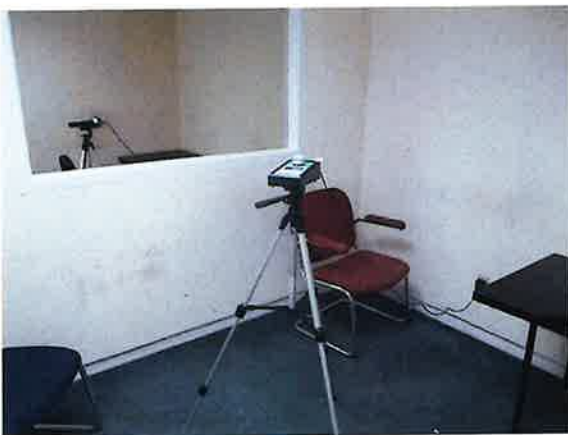
- 9) View of the inside air sample (2460-25) location in Interview Room located on the west side of the second floor. Air sample 2460-25 was not elevated when compared to the outdoor total fungi concentration.

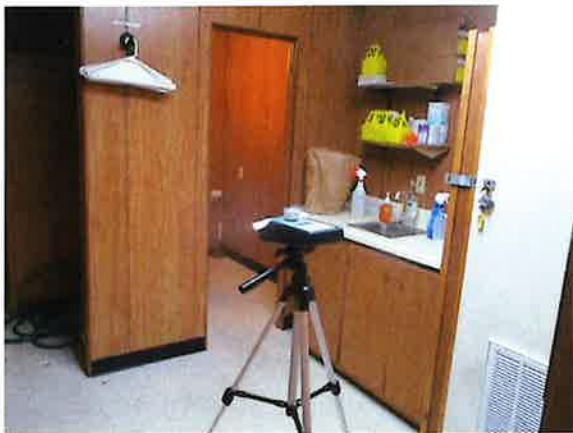
- 10) View of the inside air sample (2460-33) location in the Evidence Trailer, near the eastern side of the building. Air sample 2460-33 was not elevated when compared to the outdoor total fungi concentration.

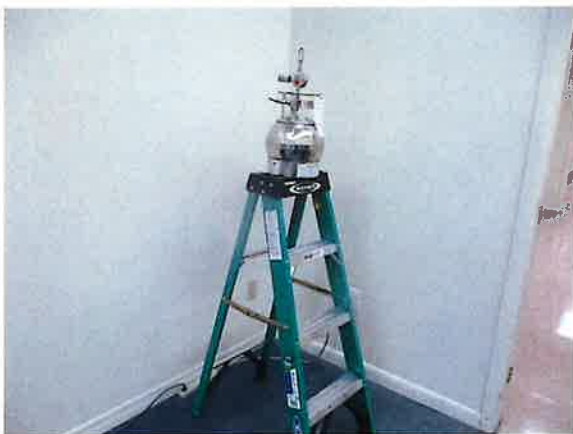
- 11) View of the Volatile Organic Compound (VOC) air sample location in the Common Area on the west side of the second floor. Sample 2460-5 VOC was collected in this location.
