**Project Name:** Environmental Remediation

**Project Location:** Exploreum Science Center  
65 Government Street, Mobile, AL 36602

**Project Number:** SR-032-20

**Gulf Coast Exploreum  
65 Government Street  
Mobile, Alabama 36602**

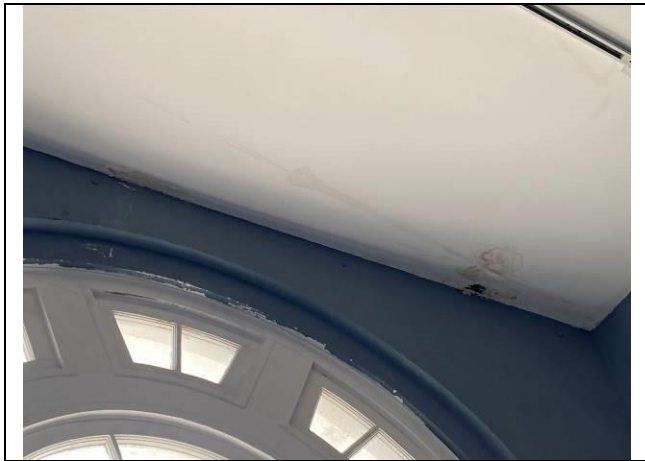
**Photo #11.** Water Damage Observed on the First SVMG Floor Ceiling

ATC recommends the destructive removal of any affected mold impacted porous materials (gypsum, wallboard, sheetrock, insulation, carpet, and cloth), to a point of two feet beyond any suspect microbial growth. If microbial growth is found, affected wood stud framing and other wood materials within contaminated wall cavities should be HEPA vacuumed, wire-brushed or sanded, and then HEPA vacuumed again to remove any superficial mold growth inside the grain of the wood, and replaced if the fungal colonization is extensive and has affected the integrity of the wood. Any sanding should be performed under negative pressure containment with a sander equipped with High Efficiency Particulate Air (HEPA filtration. All materials to be reused should be dry and visibly free from mold. After visible debris has been removed, all surfaces within the enclosed work area, decontamination room, and all other affected areas should be HEPA vacuumed and wiped cleaned. The use of water should be minimized throughout the remediation process. Do not reuse cloths during this process.
