FACILITY CONDITION ASSESSMENT

City of Mobile

Civic Center Arena

Project No. PC60828394 - 201

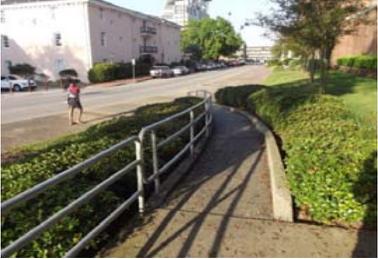
8		<p>Install Ramp Handrails at Main Arena Entrance (Pipe Rail in Concrete) Currently a handrail is only provided on one side of the wheelchair ramp accessing the Arena entrance from Civic Center Drive. Full ADA compliance requires handrails at both sides of wheelchair ramps.</p>	40	LF	\$48.00	\$1,920

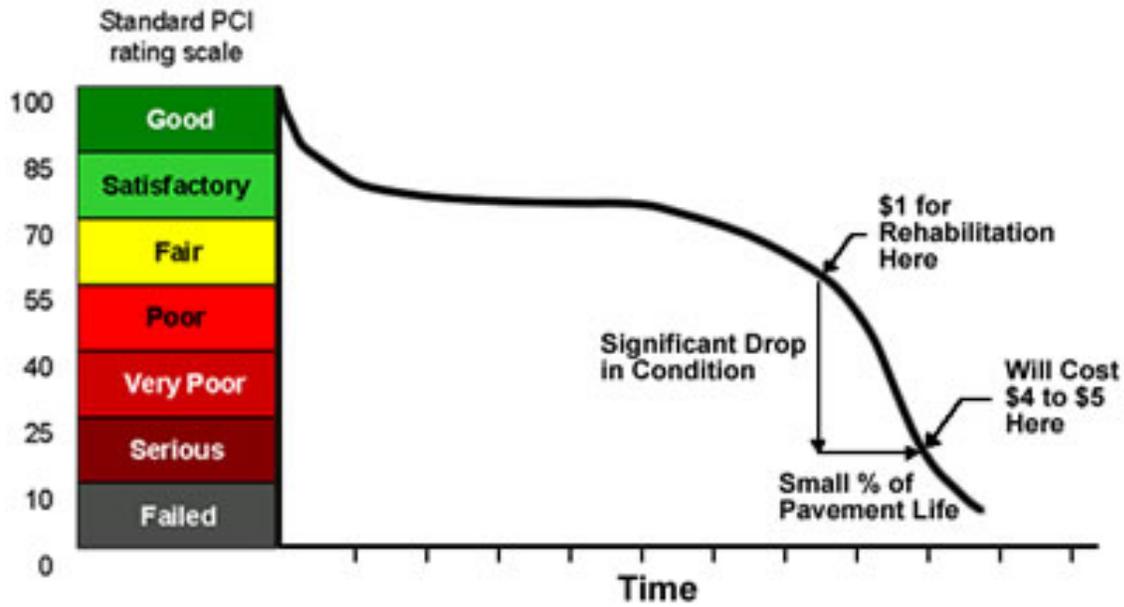
Figure 1

Each observation was assigned a numeric score based on the severity and density of the distress. The numeric score was then compared to the standard ASTM PCI rating (Figure 1) and graphed (Figure 2) to relate the aggregate PCI to near term and long-term restoration activities.

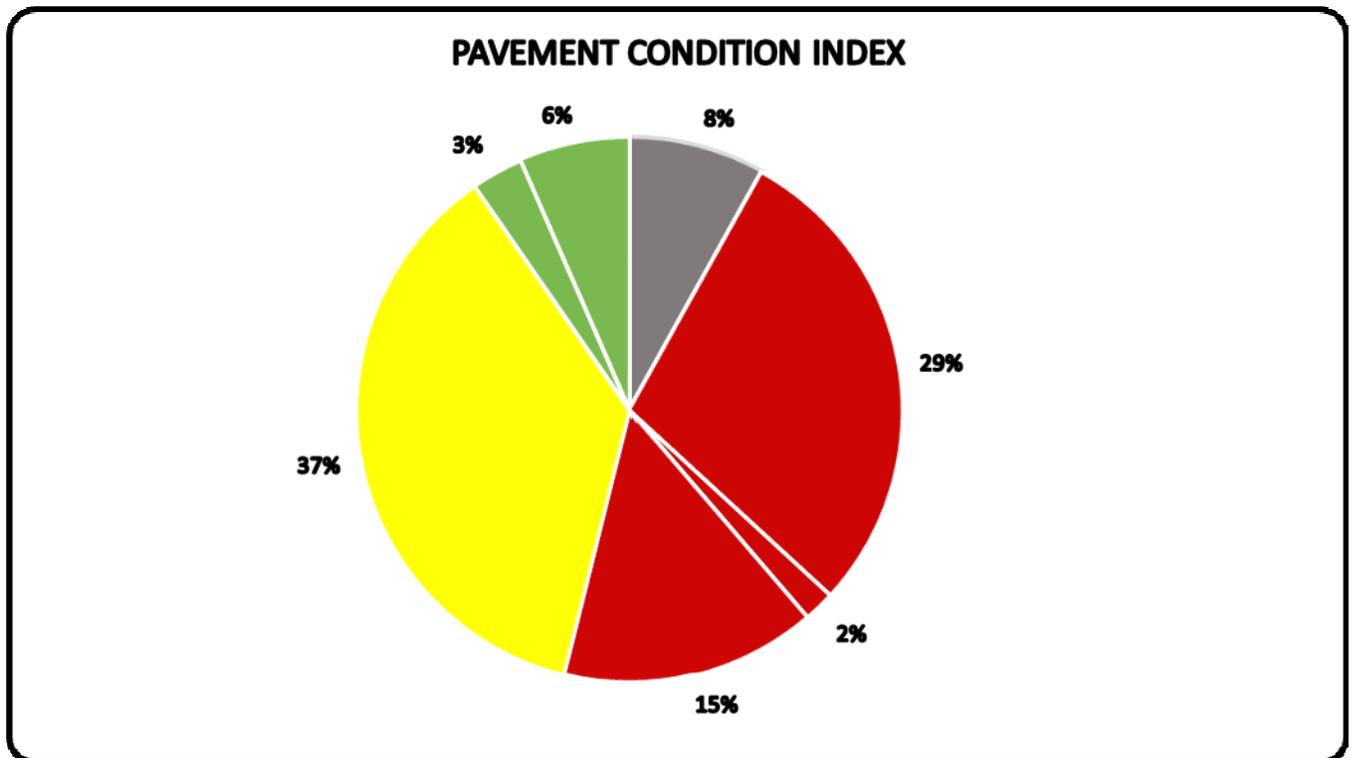
Figure 2

The findings indicate fifty four percent of the pavement condition is from poor to pavement this is considered failed. Thirty seven percent of the pavement is in fair condition. However, much of this pavement will begin to deteriorate more rapidly in the near term than experienced previously. Nine (9) percent of the pavement can be considered in satisfactory to good condition. A majority of the distress type were aggregate loss / polished aggregate and cracking. Portions of the pavement showed signs of inadequate drainage which will decrease the overall useful life likely requiring increased maintenance or premature resurfacing.

It can be expected ten to twenty percent of the pavement has failed structurally will require full depth rebuilding. The remainder of the asphalt can be overlaid. If pavement restoration is not conducted with the next two (2) years, most of the pavement will be in the poor to failed condition rating. It can be expected full depth restoration as a percentage will increase with associated cost increases. If the existing use of the facility is expected to continue, it is recommended that structural repairs to the underlying base materials take place and one hundred percent of the asphalt be replaced with the next two (2) years..

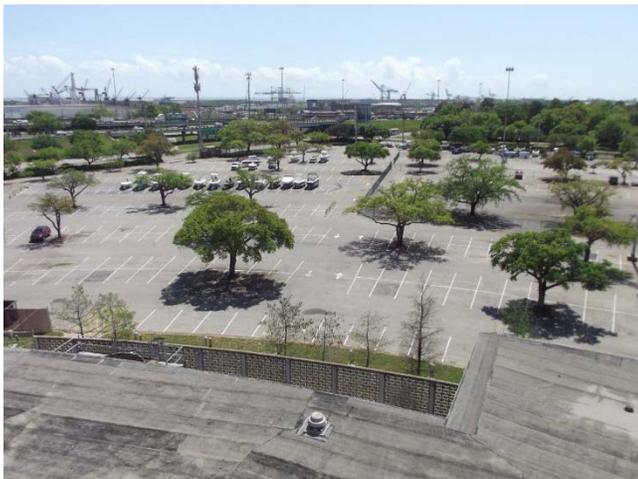
3. Parking for 1,400 cars is provided in asphalt-paved surface lots which are shared by the entire Civic Center complex.

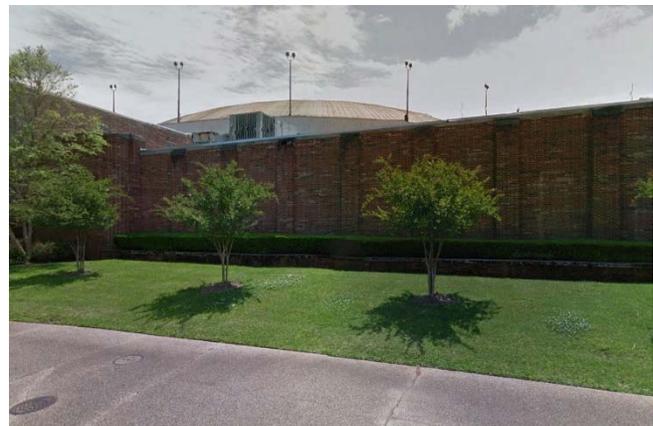
12. North elevation of the west Exhibit Hall. Exterior sidewalls are clad with brick veneer over a CMU back-up system. Note exterior planters.

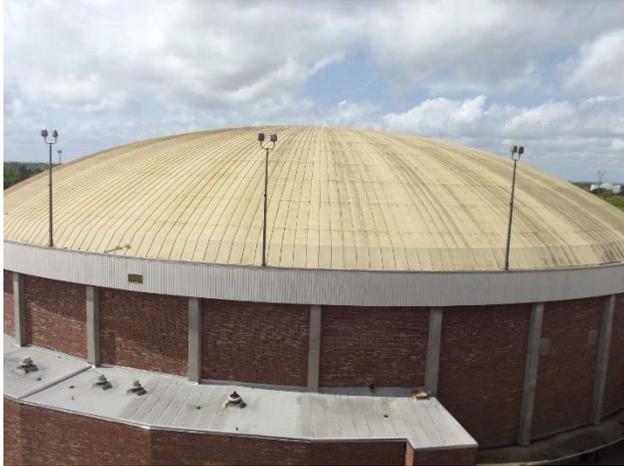
19. Overview of the domed arena roof. Note dome lighting standards have hinged connections for servicing.

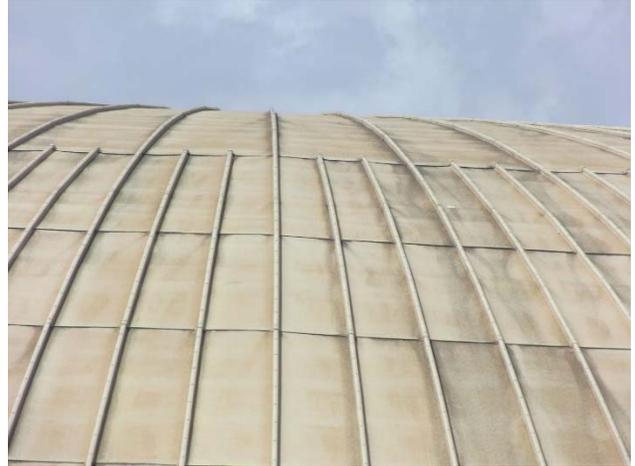
20. The dome roof is covered with a metal batten roofing system that dates from the original construction and is 53 years old.

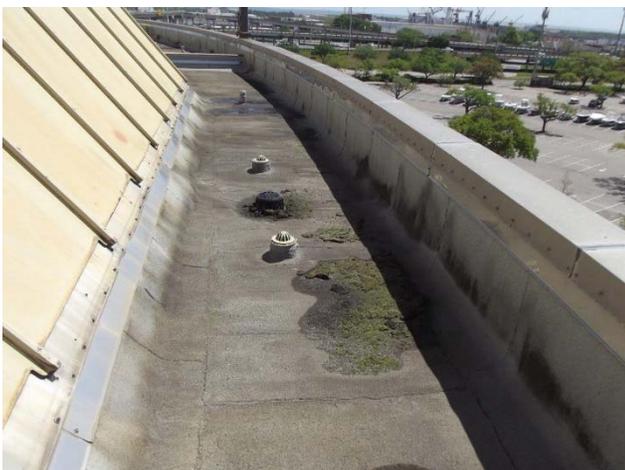
23. All water from the dome drains to the Dome Gutter roof, which is clad with a BUR system with a mineralized cap sheet.

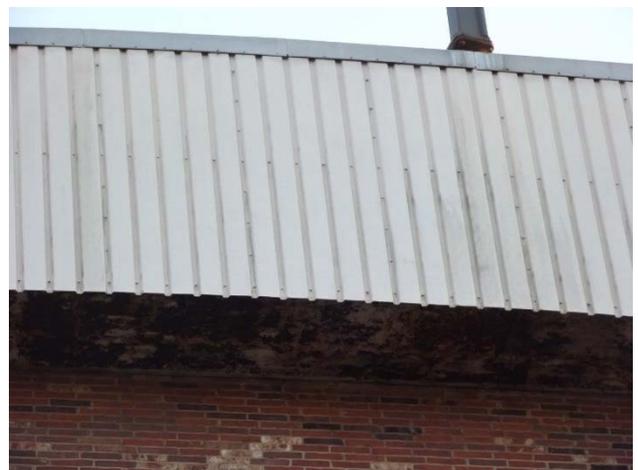
24. The outboard side of the dome gutter parapet is clad with a metal panel system.

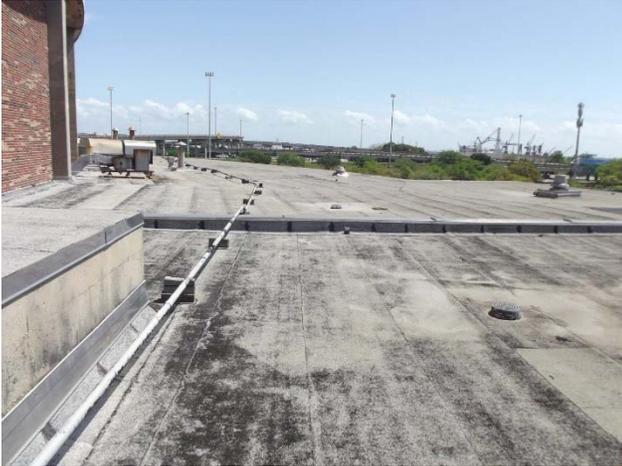
25. South side service area roof. Lobby and service areas are covered with BUR roofing systems with mineralized cap sheets.

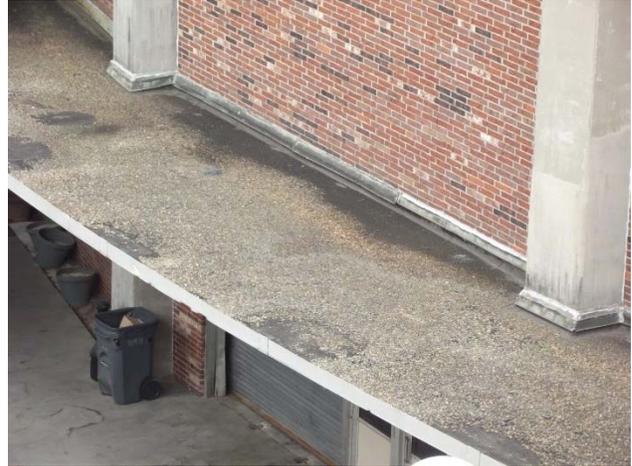
26. Projecting canopies over the secondary public entrances are covered with gravel surfaced coal tar roofs believed to date from the original construction and are 53 years old.

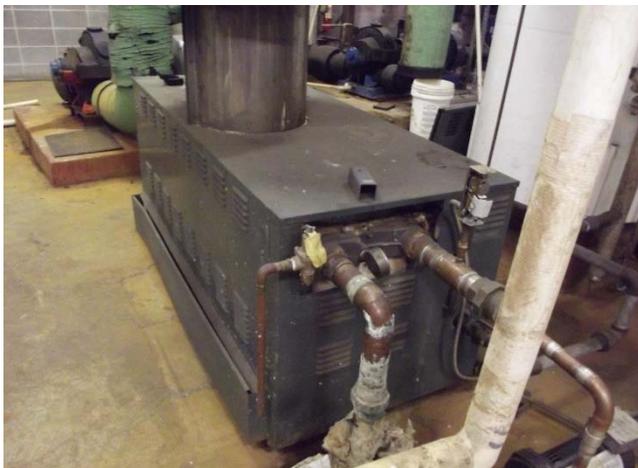
53. Domestic Hot Water Boiler 3. Domestic hot water is primarily generated by two gas-fired water heaters.

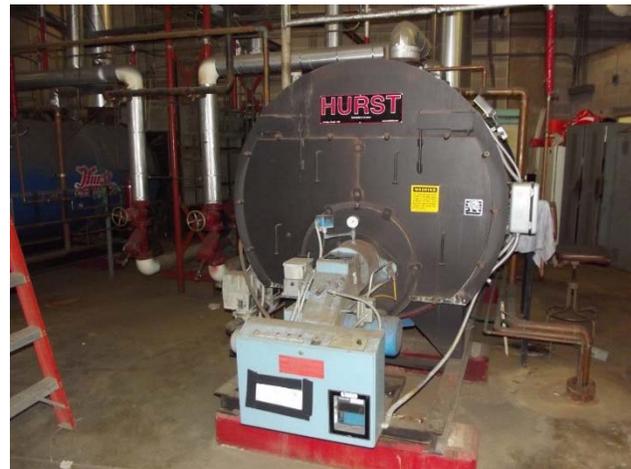
58. Steam for heating is generated by a pair of gas-fired boilers manufactured by Hurst.

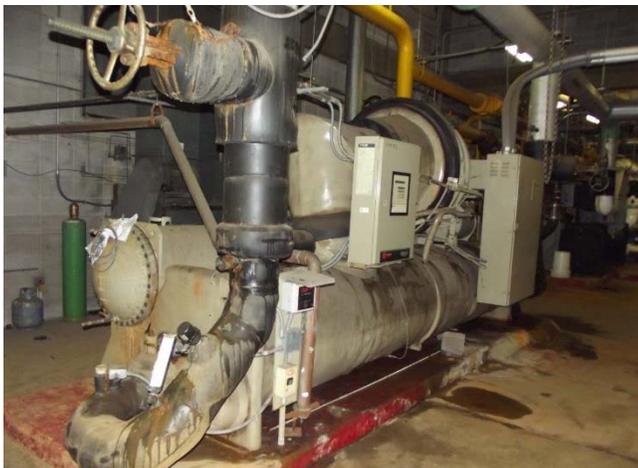
59. Chilled water is generated by two chillers. The 400-ton Unit (R-123A) manufactured by Trane dates from a 1997 installation.

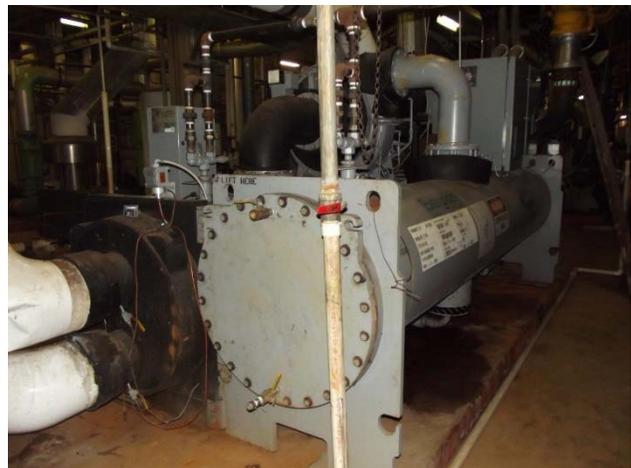
60. A 500-ton Unit utilizing R-134 refrigerant was manufactured by Trane dates from a 2002 installation.

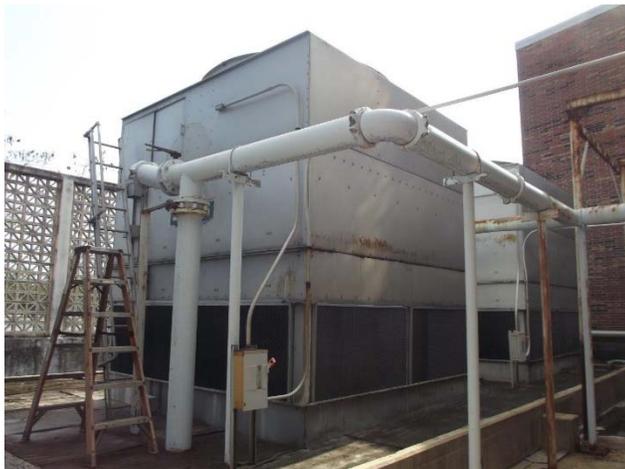
63. Heat rejection is partially provided by a paired set of 2011 cooling towers with rated capacities of 400-tons each manufactured by Evapco.

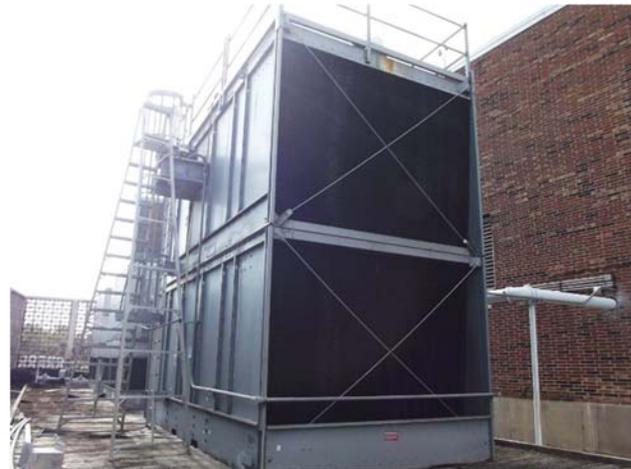
64. The third cooling tower has a rated capacity of 784 tons, was manufactured by Marley, and dates from a 2006 replacement.

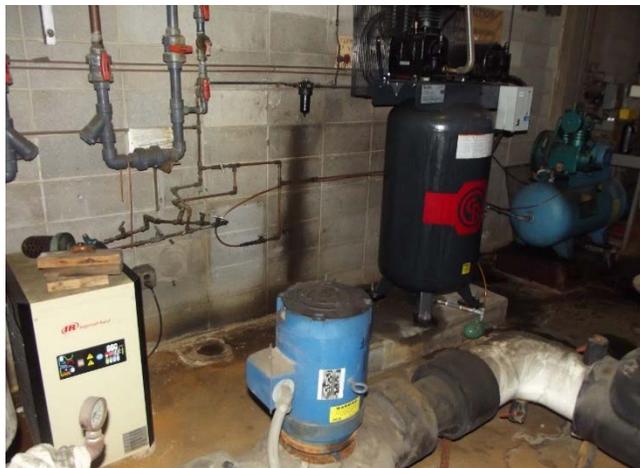
65. The central plant is complete with various air compressors and dryers for the control system.

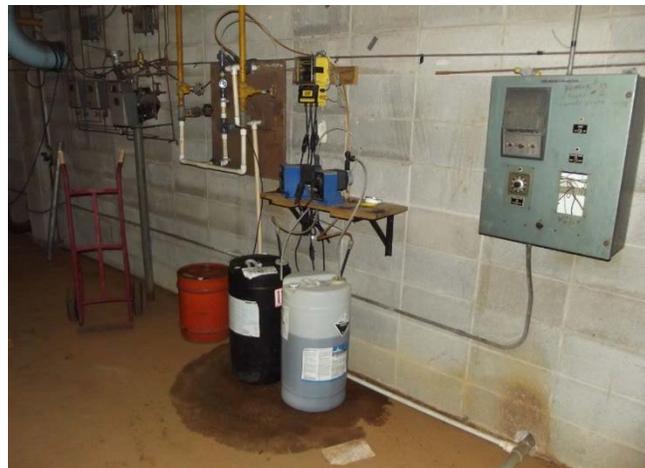
66. A water treatment station for the cooling towers is also provided.

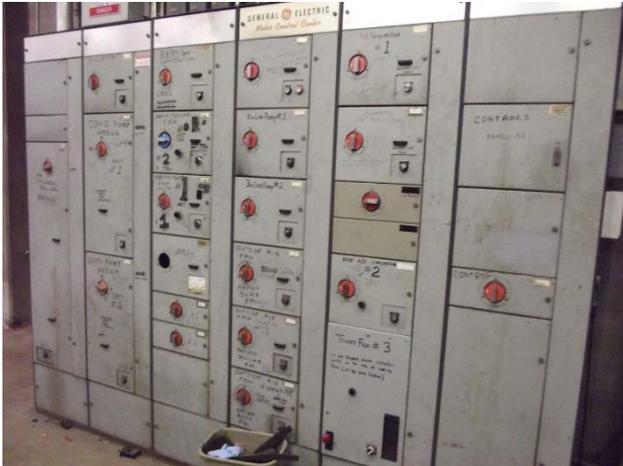
67. The motor control center at the central plant dates from the original construction and is 53 years old.

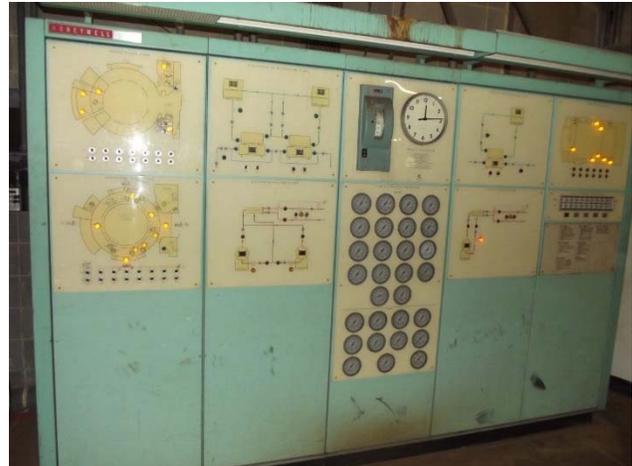
68. Central plant equipment is controlled by a Johnson Controls Metasys BMS system using pneumatic controls partially run through a control panel dating from the original construction.

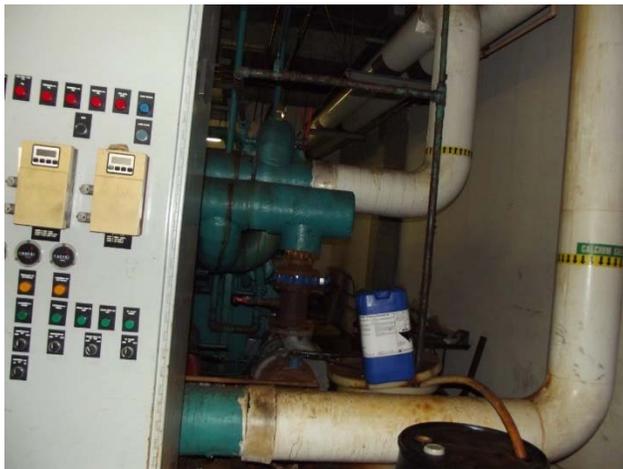
69. Chilled water for ice-making was generated by a single 212-ton chiller manufactured by Cimco Lewis that dates from a 1995 installation.

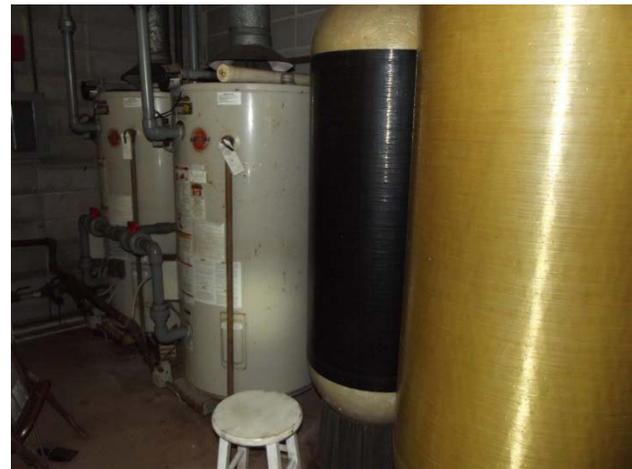
70. Water treatment and hot water generating equipment for the ice-making function have been abandoned in place.

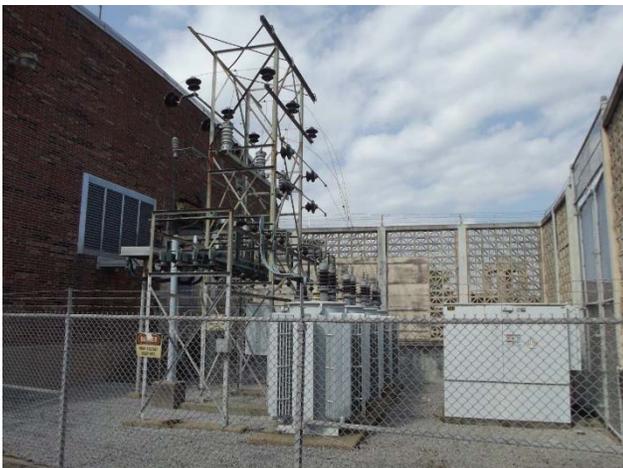
71. Electrical power is fed directly from an on-site Alabama Power substation located next to the exterior cooling tower enclosure.

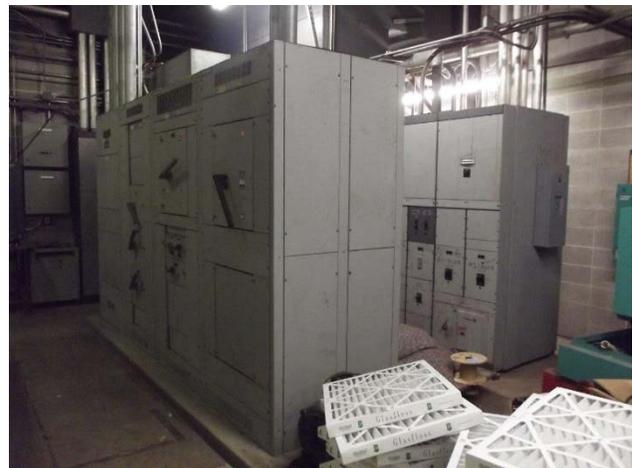
72. Main electrical switchgear at the central plant has disconnects rated as follows: 1 each at 4,000 and 1,200 amps, and 2 at 1,600 amps at 480 volts.

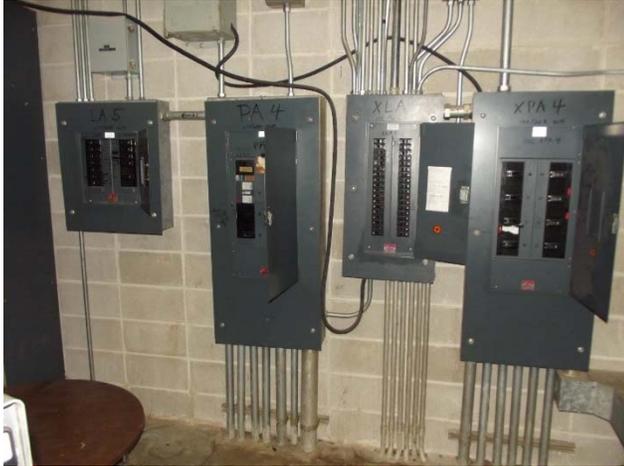
73. Electrical distribution is via circuit breaker panels that are generally original to the building and 53 years old.

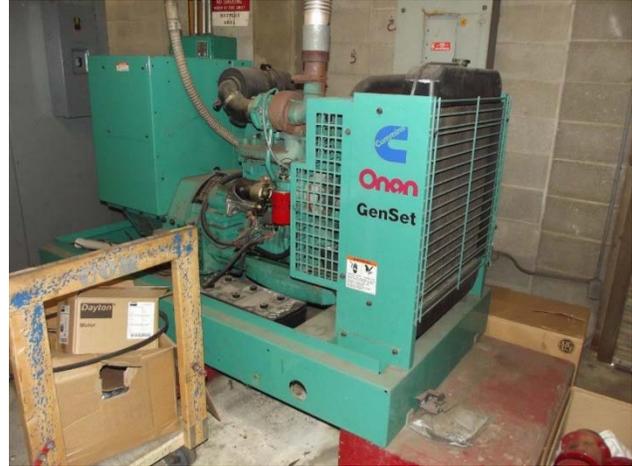
74. Emergency power for emergency and egress lighting is provided by a single 35 kW diesel fired generator manufactured by Onan.

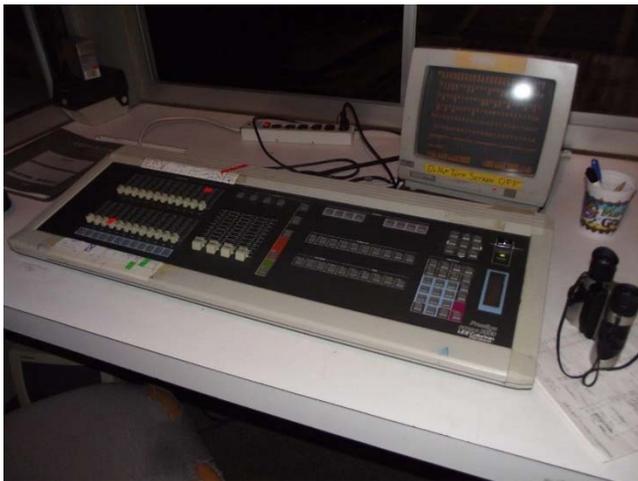
75. The Color Tran theatrical lighting control system for the arena dates from 1989.

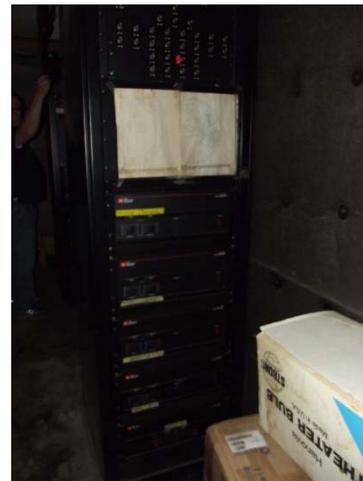
76. The building is improved with a JBL Cluster sound system that dates from 1989.

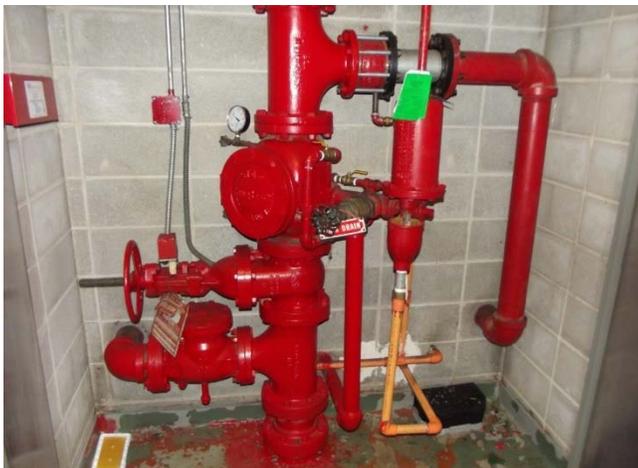
77. Fire protection is primarily provided by a standpipe system with limited sprinklers provided at backstage, storage, and commercial kitchen areas.

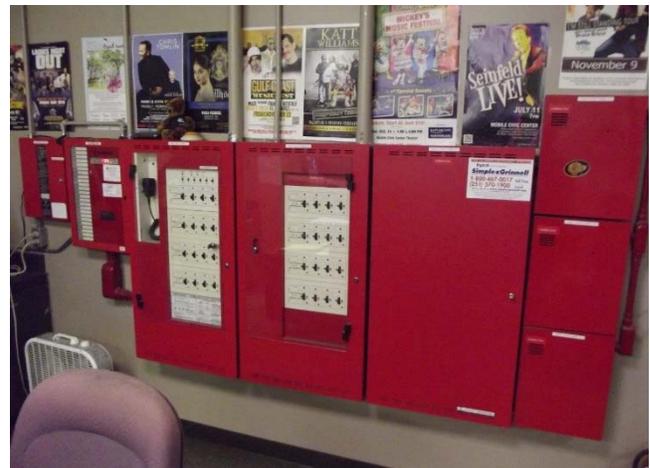
78. A fire alarm system supervises the standpipe and limited sprinkler systems and is monitored by a central station.

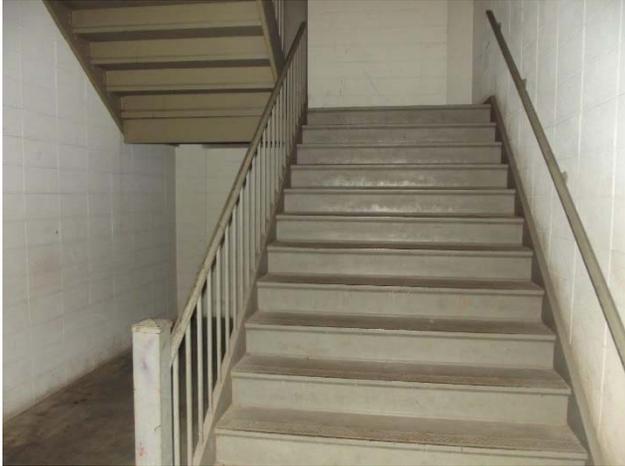
79. Emergency egress is primarily provided by stairs in fire-rated enclosures.

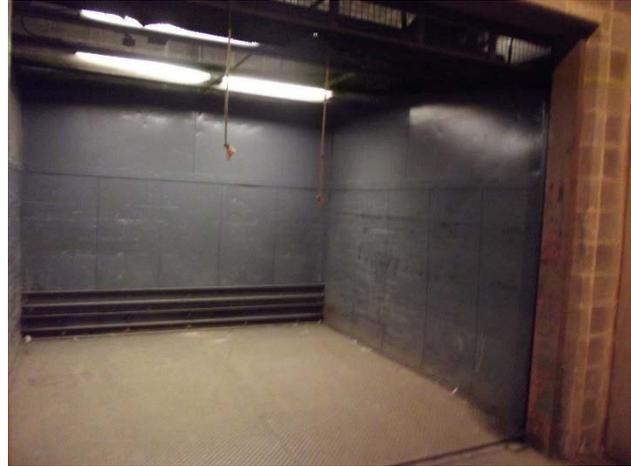
80. Vertical transportation includes a single hydraulic freight elevator with a rated capacity of 8,000 lbs. that is original to the building and has a manually operated door.

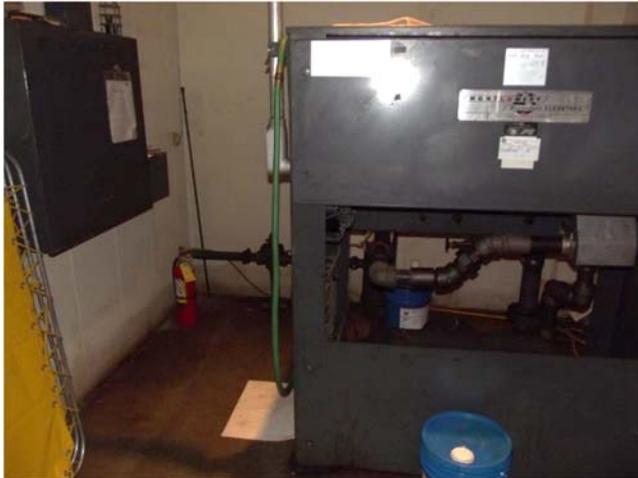
81. Elevator machine for the freight car.

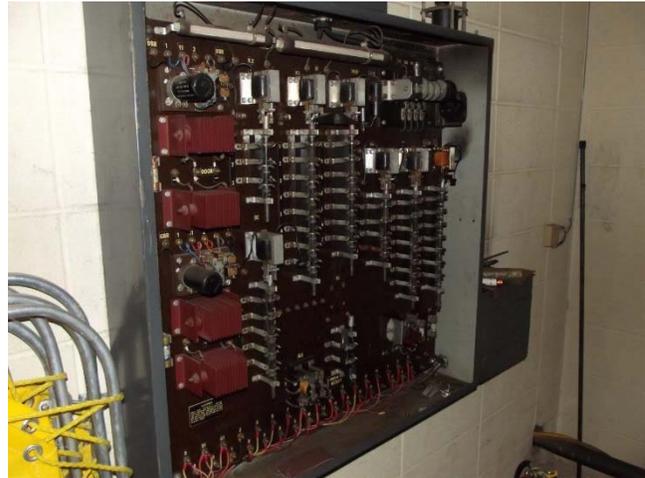
82. The freight car is controlled using relay type controls.

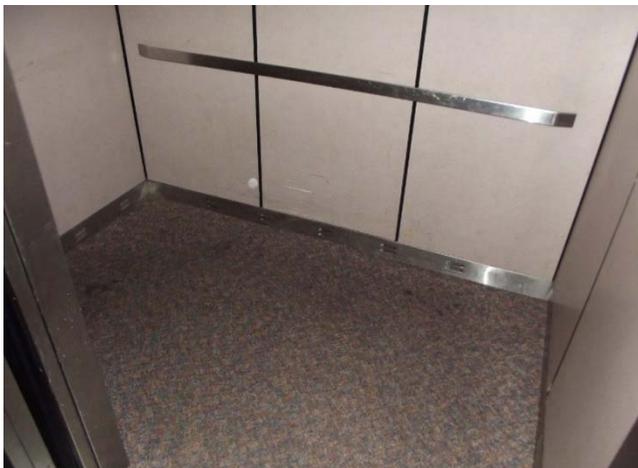
83. The single hydraulic passenger elevator has a capacity of 2,500 lbs. Finishes consist of commercial carpet and plastic laminate wall panels.

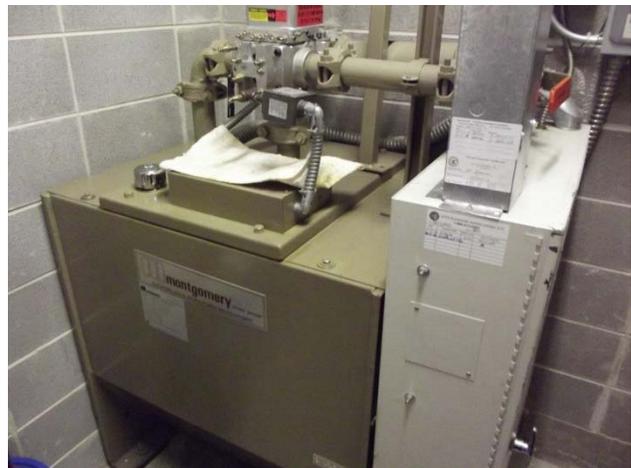
84. The hydraulic passenger elevator machine and controls date from a 1989 installation.
